## Chapter 3 Restoration Work

### Section 1 Restoration of the South Stairways of the Central Sanctuary

## Section 2 Bonding of Sandstone Blocks

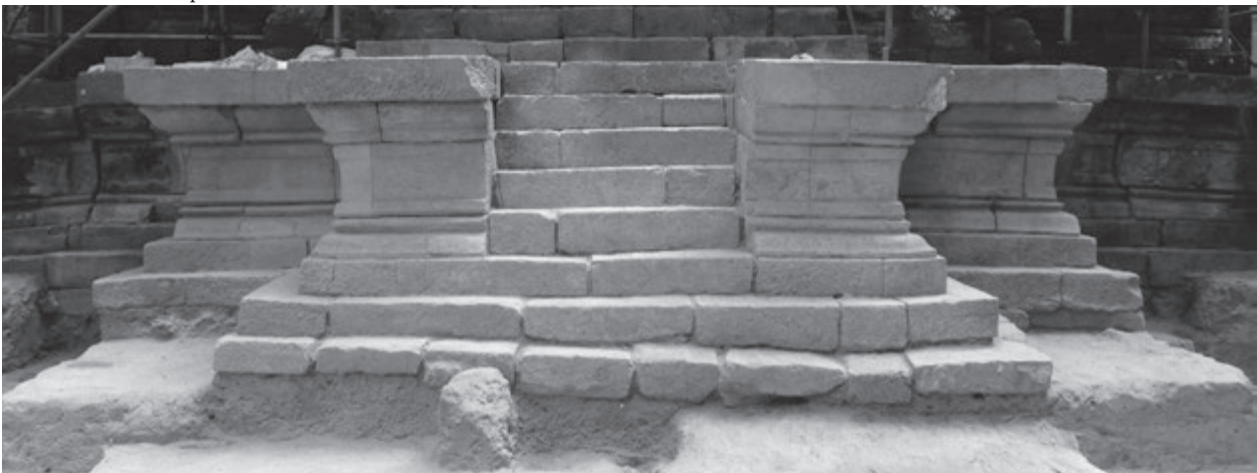
Fig. 37: South stairways of the Central Sanctuary after restoration

Prior to reassembly the Southern Sanctuary, the south stairways of the Central Sanctuary were partially restored, as it would be buried within the foundation. The stairways were buried in the earthfill of the foundation of the Southern Sanctuary when the sanctuary was built, and N18 was paved on top of the lower platform of the Southern Sanctuary. On top of N18 stood the main structure of the sanctuary. Platform stone SN133 and two other stones paved immediately below the structure were cracked or fractured in the southwest direction, corresponding to the settlement and inclination direction of the entire structure. In the recent restoration work, these three blocks were restored and returned to their original positions.

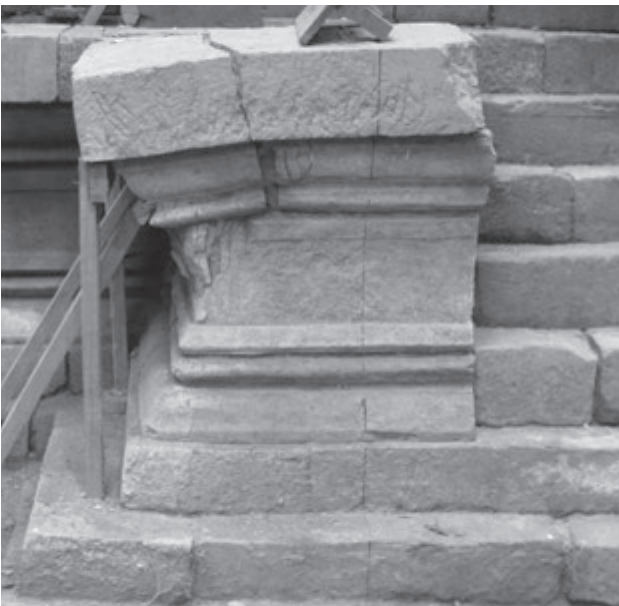
Fig. 38: Before restoration

The west half of SN133N18 shown in Fig. 38 was broken, so the original block was bonded together. SN137 behind it was also broken in the southwest corner, but unlike SN133, it was broken into small pieces, so it was bonded using new materials. Immediately below SN133, the stone block with moldings that was found among the edging stones of N19, was used as it is, as the stone itself was only minimally damaged. The N20 stone panel displayed a special state of damage in the southwest corner as shown in Fig. 39, so that portion was replaced with new material. On the west side of the stone panel, as shown in Fig. 41, details of the moldings were damaged and the stone was cracked into three pieces. Judging that sufficient strength cannot be restored even if the block is bonded, it was replaced with a new material.

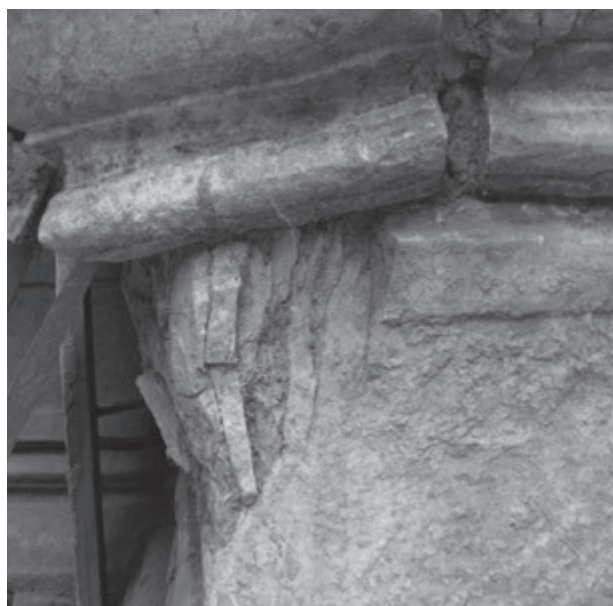
Fig. 39: Damage to a stone panel

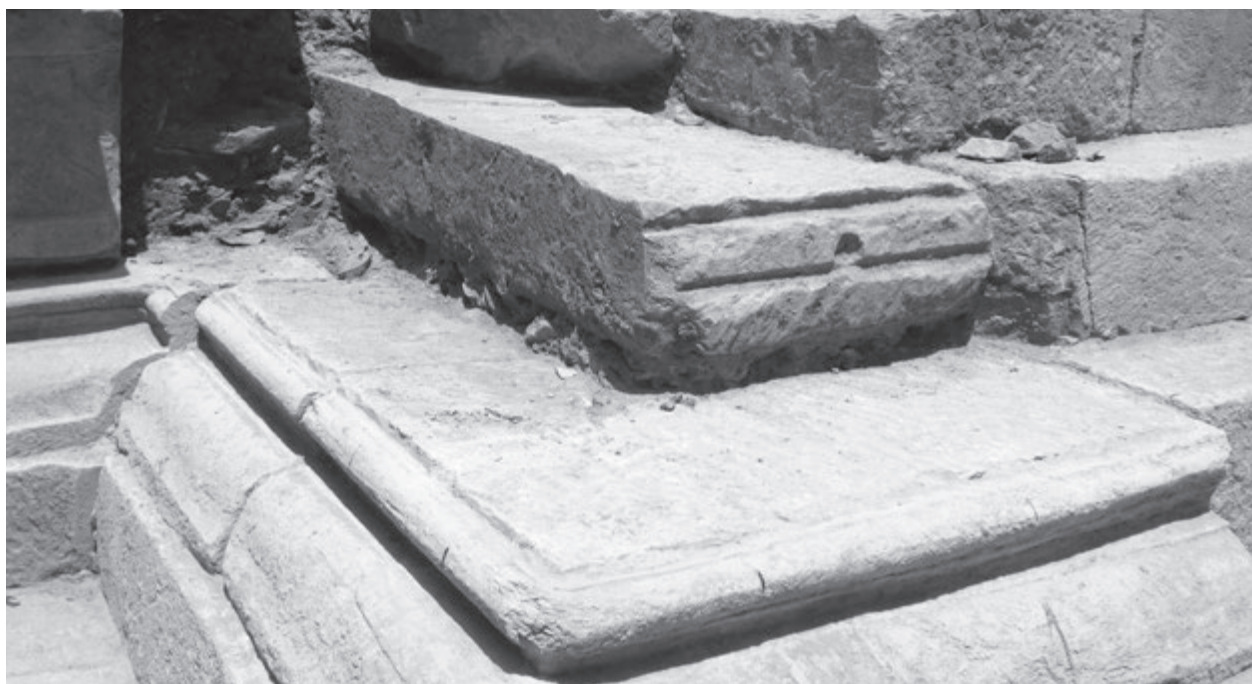
Accompanying this restoration work, part of the south stairways of the Central Sanctuary was dismantled, and a diverted sandstone was discovered, as shown in Fig. 43. The fact that it resembles the diverted blocks found in N21 and N23, as will be discussed later, is a source of interest.

Fig. 43: South stairways of the Central Sanctuary diverted stone blocks on the inner side of the west sleeve area

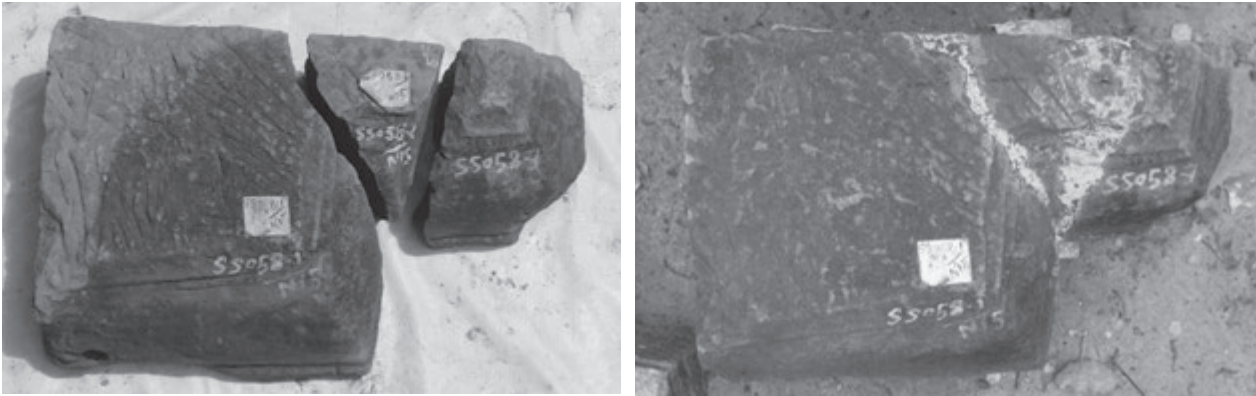
Fig. 44: Restoration of stone block SS058N15 left: before restoration; right: after restoration

In conjunction with the dismantling of the Southern Sanctuary, damaged stone blocks were bonded one after the other. Two holes 10 ~ 20 cm deep were made in the bonding faces, stainless steel bolts were inserted in them, and the two parts were secured with epoxy resin. This method is commonly used in the restoration of the Angkor monuments, and was also adopted as the method for bonding stone blocks in this project. Gaps between the bonded faces were filled with spacer material made of epoxy resin and sandstone powder, and the excess resin that leaked out from the edges was scraped away after it hardened.

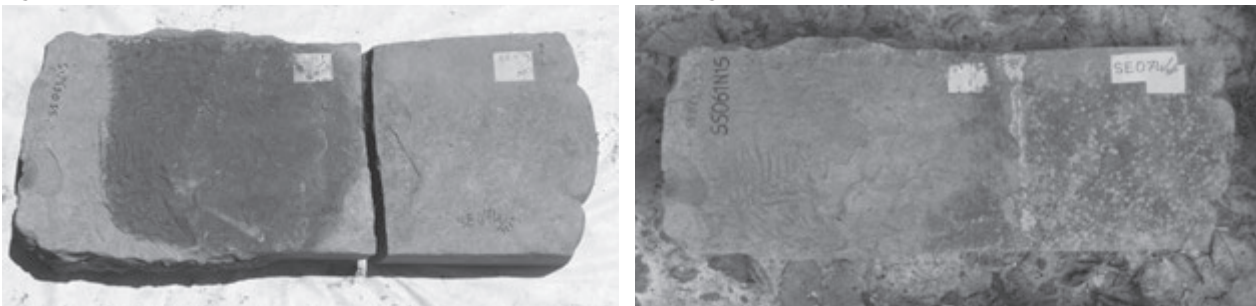
Fig. 45: Restoration of stone block SS061N15 left: before restoration; right: after restoration

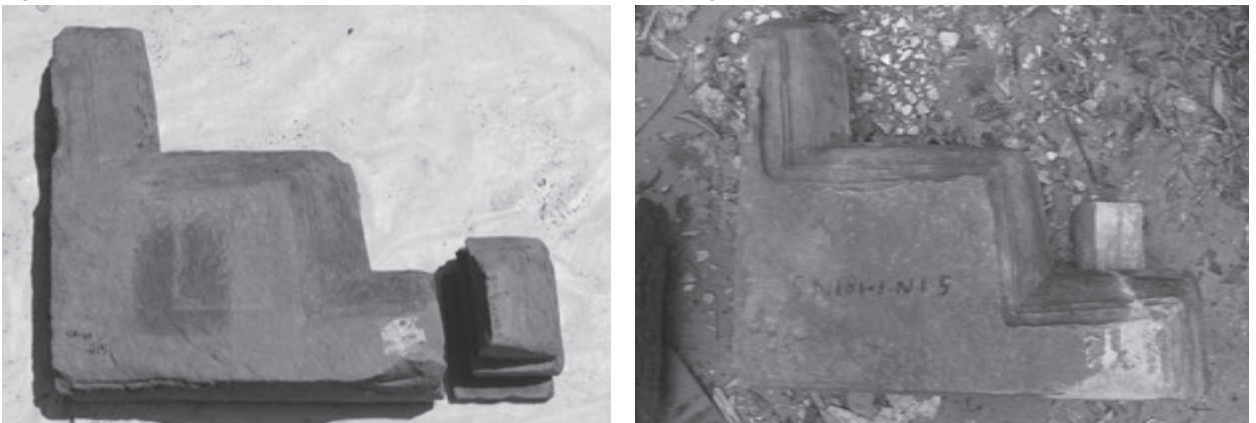
Fig. 46: Restoration of stone block SN101N15 left: before restoration; right: after restoration

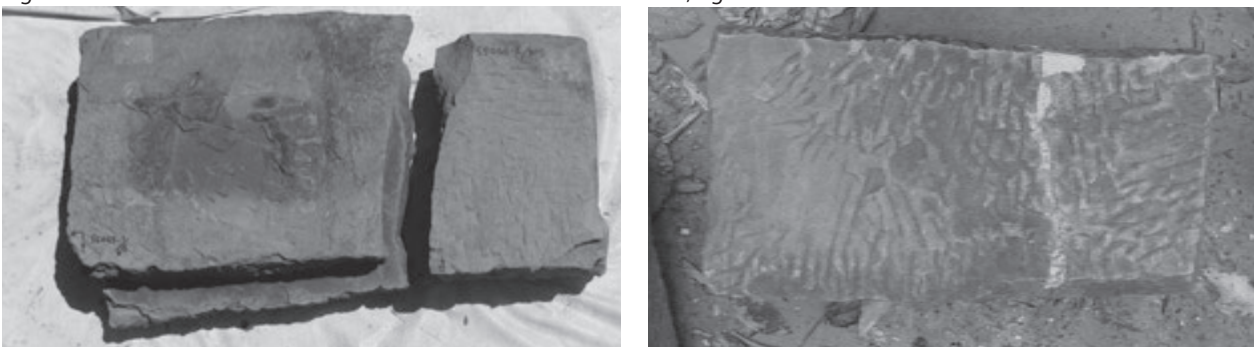
Fig. 47: Restoration of sandstone SS065N15 left: before restoration; right: after restoration
