I. Report of Conservation works

Chapter 1 Process of the Dismantling Work

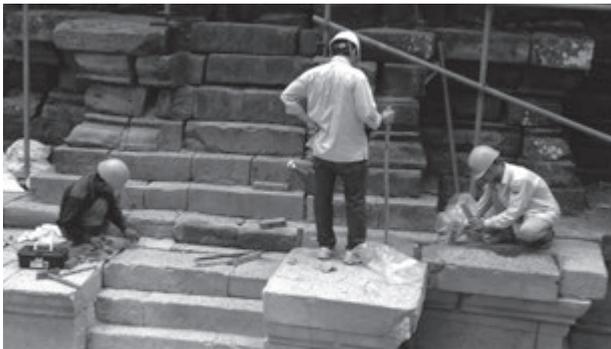
Fig. 1: Restoration of the south stairways of the Central Sanctuary

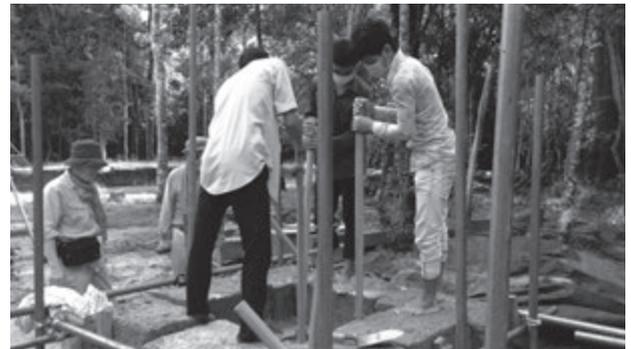
Fig. 2: Test foundation earthfill

In June 2013, test earthfill was prepared for two places on the south side of the Southern Sanctuary to collect data for improving the foundation soil. In July, a conservation science survey was conducted, the mixing ratio for the consolidated filling soil of the foundation was decided, and preparations were made for producing laterite powder and clay powder. The basement digging ground was also investigated as required, and buried pottery was discovered. In September, N23 was dismantled. Upon completion of the dismantling of N23, it was decided that the connecting area between the upper blocks of the foundation of the Southern Sanctuary and the Central Sanctuary should be examined, and the Architecture Unit made an examination in October. A 3D survey was conducted once again in November by Kyowa Corporation, mainly of the connecting area with the Central Sanctuary. In November, after the rainy season had ended, the dismantling of N24 and N25 was begun. As these two tiers were made almost entirely with laterite and their dismantling and removal required the excavation of their surrounding area as well, an area roughly 1m around the outer circumference of the foundation was excavated. In that process, more buried pottery artifacts were discovered from two locations outside the south side of the foundation.
