Chapter 3 Restoration Work

Section 1 Restoration of the South Stairways of the Central Sanctuary

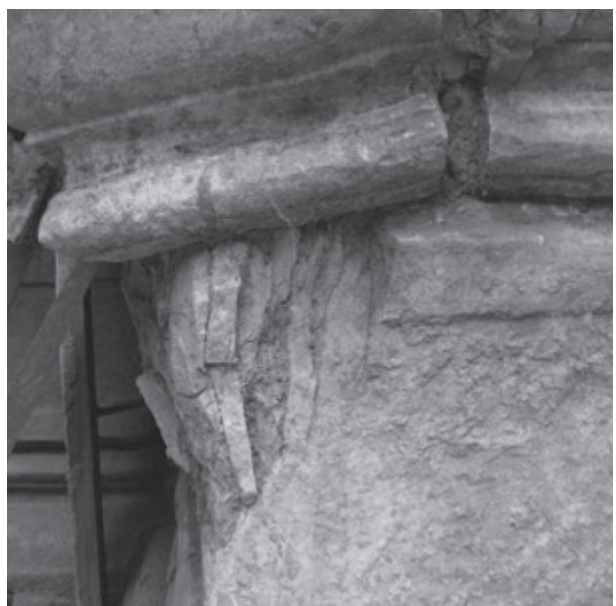
Fig. 39: Damage to a stone panel

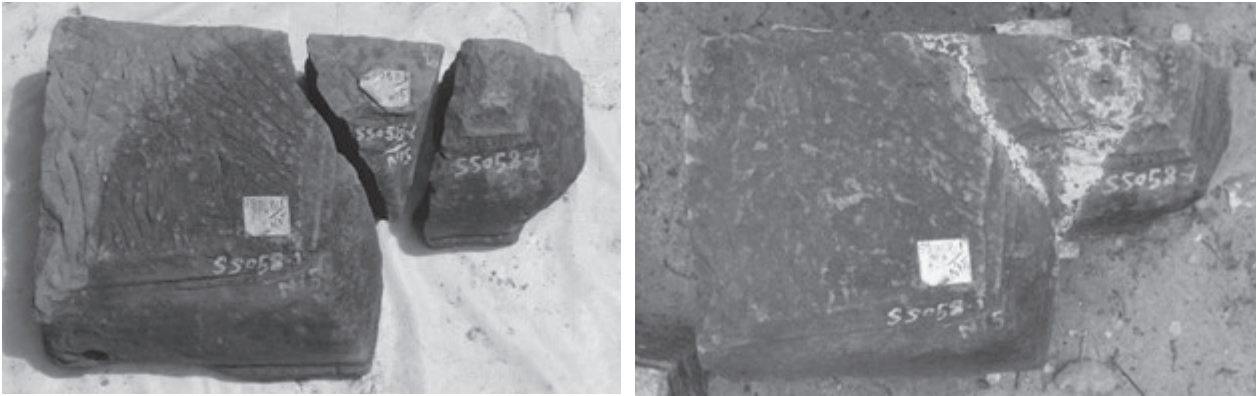
Fig. 44: Restoration of stone block SS058N15 left: before restoration; right: after restoration

In conjunction with the dismantling of the Southern Sanctuary, damaged stone blocks were bonded one after the other. Two holes 10 ~ 20 cm deep were made in the bonding faces, stainless steel bolts were inserted in them, and the two parts were secured with epoxy resin. This method is commonly used in the restoration of the Angkor monuments, and was also adopted as the method for bonding stone blocks in this project. Gaps between the bonded faces were filled with spacer material made of epoxy resin and sandstone powder, and the excess resin that leaked out from the edges was scraped away after it hardened.

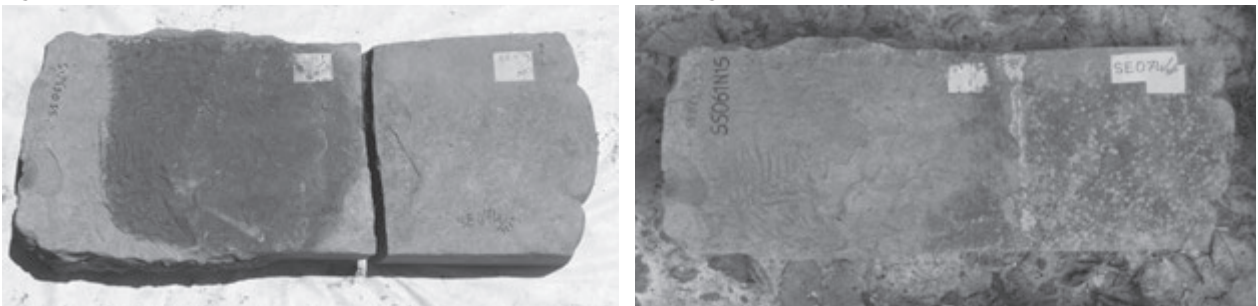
Fig. 45: Restoration of stone block SS061N15 left: before restoration; right: after restoration

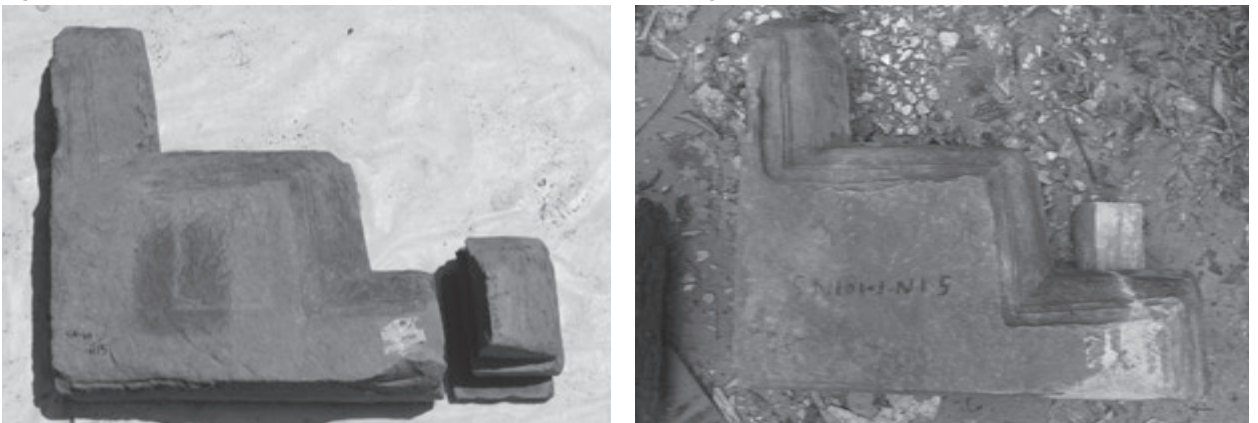
Fig. 46: Restoration of stone block SN101N15 left: before restoration; right: after restoration

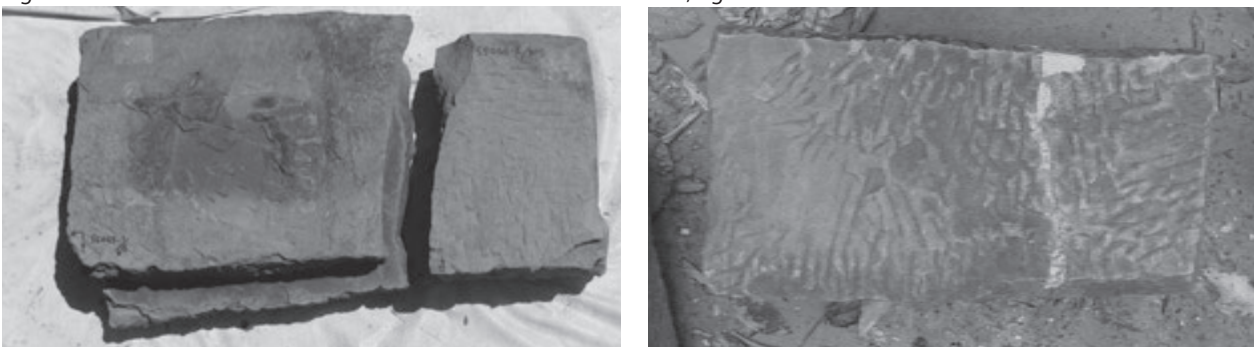
Fig. 47: Restoration of sandstone SS065N15 left: before restoration; right: after restoration
