建築学的調査 Architectural Investigations

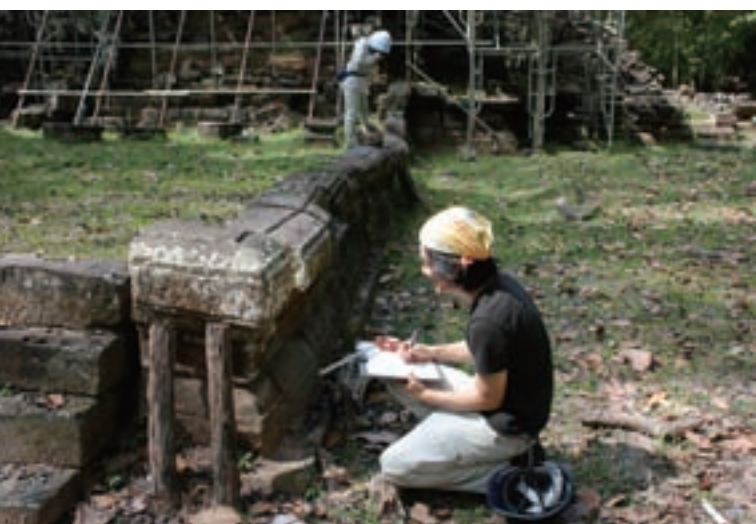
巻尺を用いて各部材を手測りする

Each member is measured by tape measure

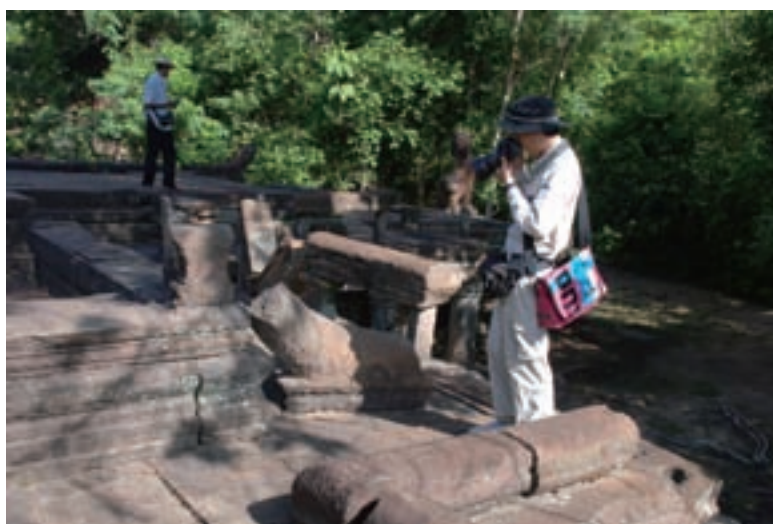
他の遺跡の類例を調査する

Survey at other sites for comparison
