## Chapter 4 Survey of the Foundation

### Section 1 Survey of the Digging Work

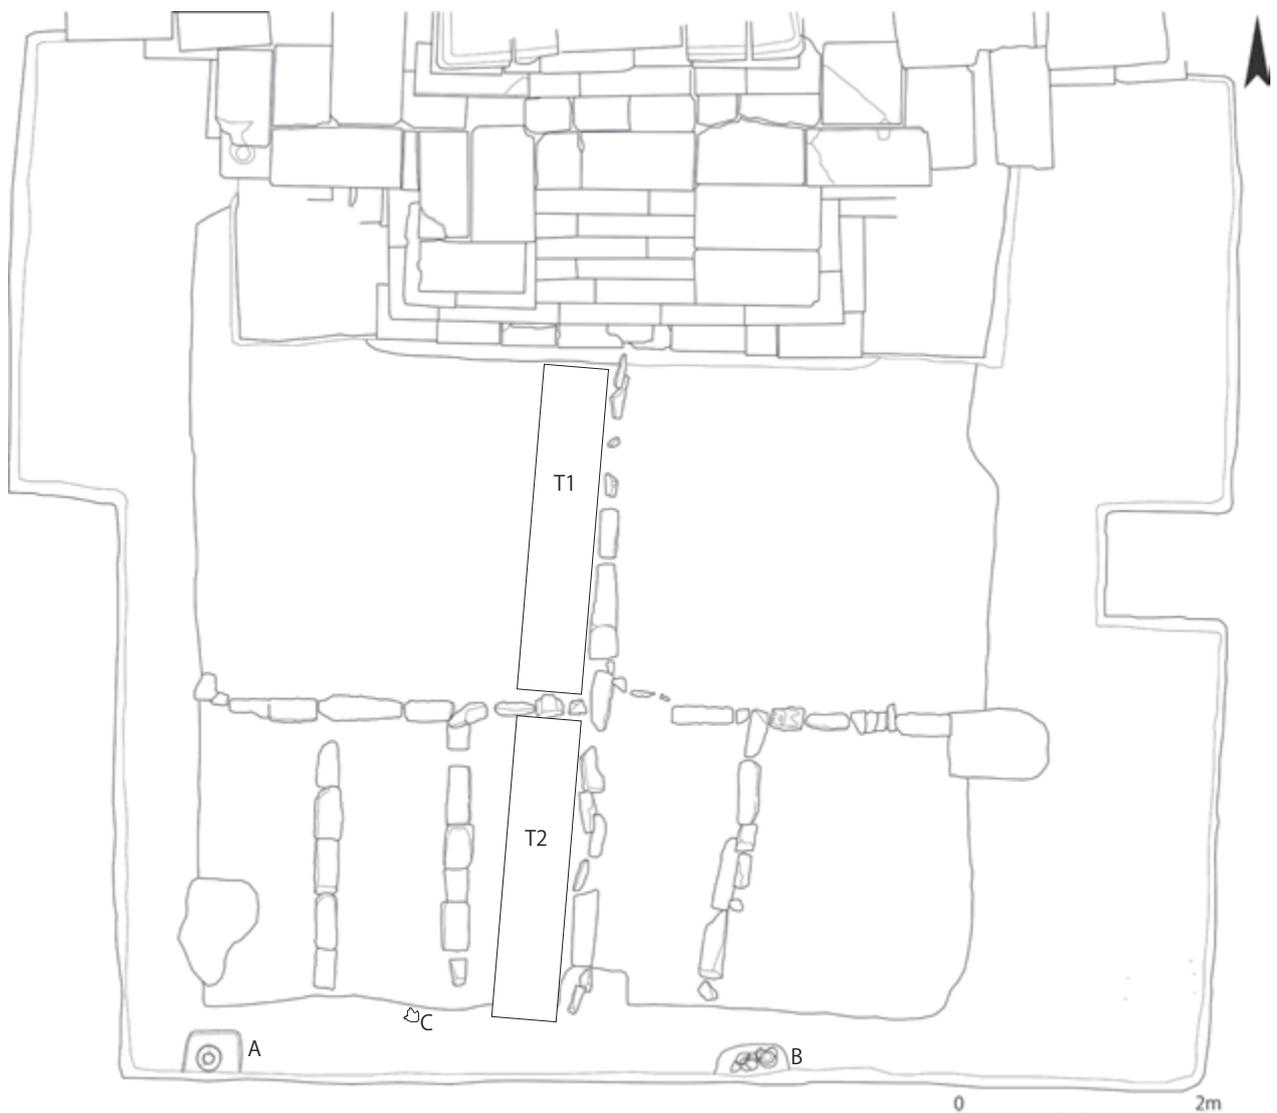
Stone lines were discovered in the foundation, as shown in Fig. 48, basically with a cruciform ground plan. The cruciform lines divide the platform digging ground into four compartments. Inside the southwest compartment are two stone lines in the north-south direction, and inside the southeast compartment is a stone line also in the north-south direction. The lines are a mixture of sandstone and laterite stones, and include blocks diverted from a statue of an old woman in the east-west line. The height of the stone lines measures approximately 1.45m from the top surface of the stones to the bottom surface of N18, and measures approximately 0.6m between the largest stone to the bottom of the foundation digging work. In other words, the lines are installed in the middle of the foundation ground. Their purpose thus poses a question. A number of possibilities can be conceived, including their use as retaining stones for the compacted soil in the digging work, or as a reference for marking north-south and east-west lines in the digging work. However, any conclusion shall be made after acquiring more similar examples.

Fig. 48: Stone lines in the foundation ground plan

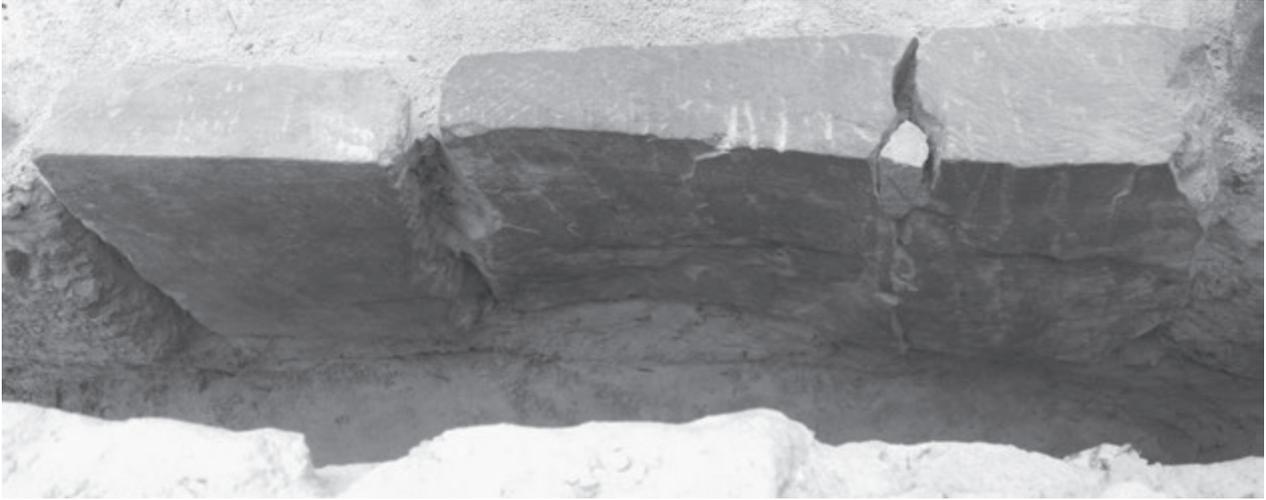
The five northern stones and one southern stone are relatively large, flat stones arranged vertically. The height of these six stones is practically aligned with each other. Other small stone blocks, however, vary in size and shape, and are uneven in height. As a result of this survey, the state of the digging line and the bottom of the basement digging ground was ascertained in part. The basement digging ground has been dug down diagonally, and the bottom is considerably uneven.

Fig. 49: Stone line in the foundation north cross-section (viewed from the west)

The stone lines in the foundation were decided to be excavated no further, but basically preserved as they are. For this reason, a detailed investigation of all stone lines was foregone, but a partial trench was opened on the west side of the north-south line of stones in the center to examine its cross section. The cross section is shown in the figure below.

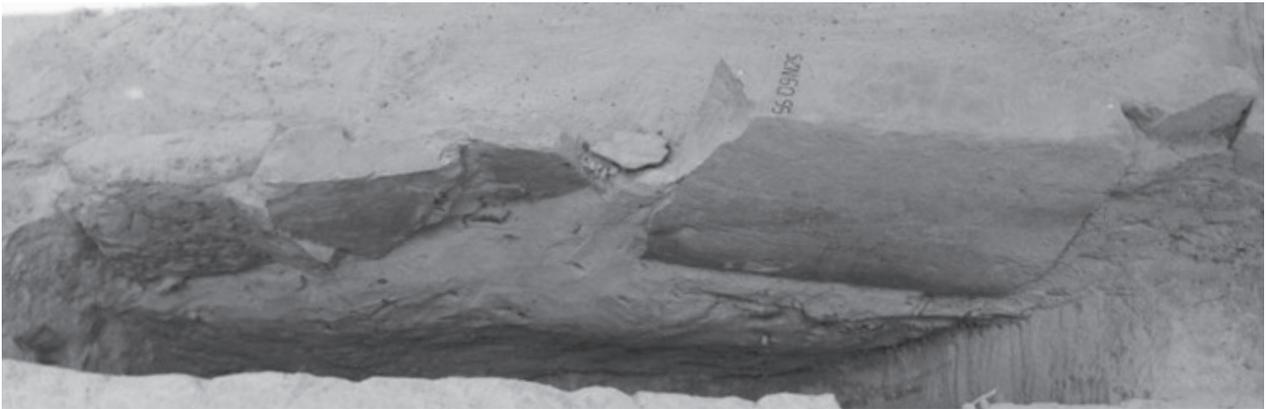
Fig. 50: Stone line in the foundation south cross-section (viewed from the west)

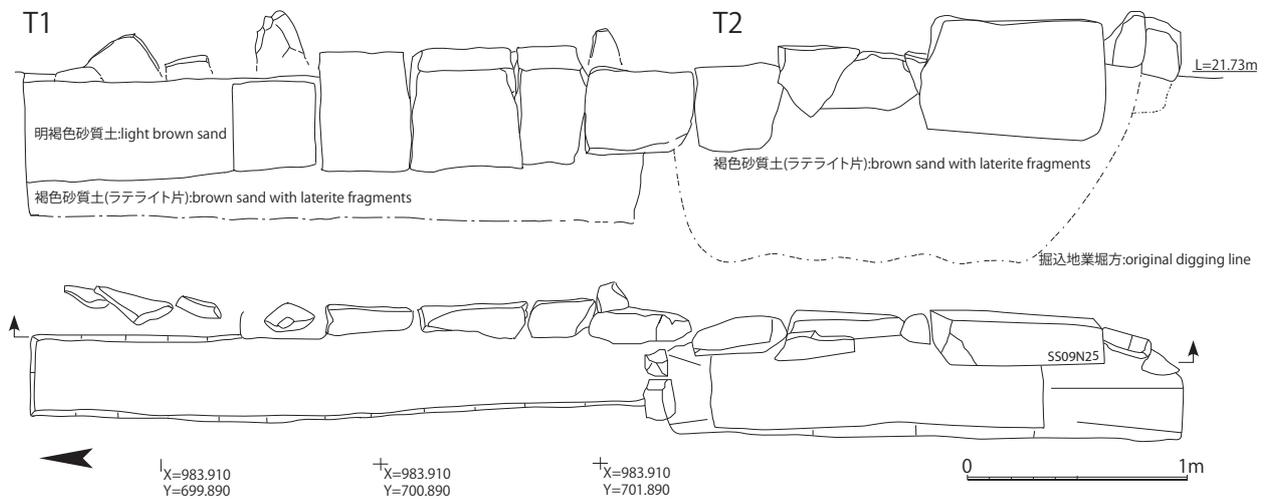
Fig. 51: Stone line in the foundation north-south cross-section

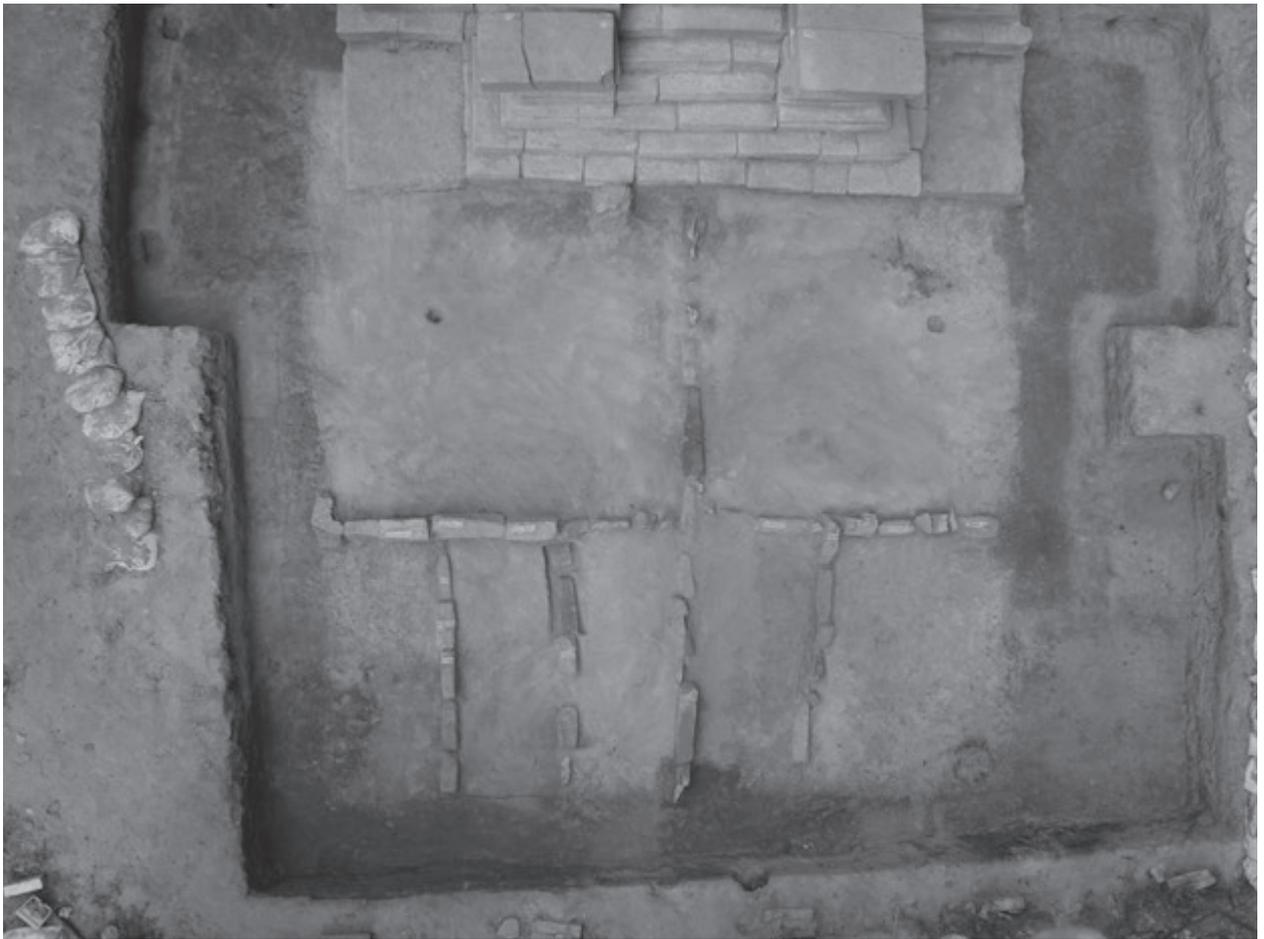
Fig. 52: Digging work and the stone lines in the foundation overhead view

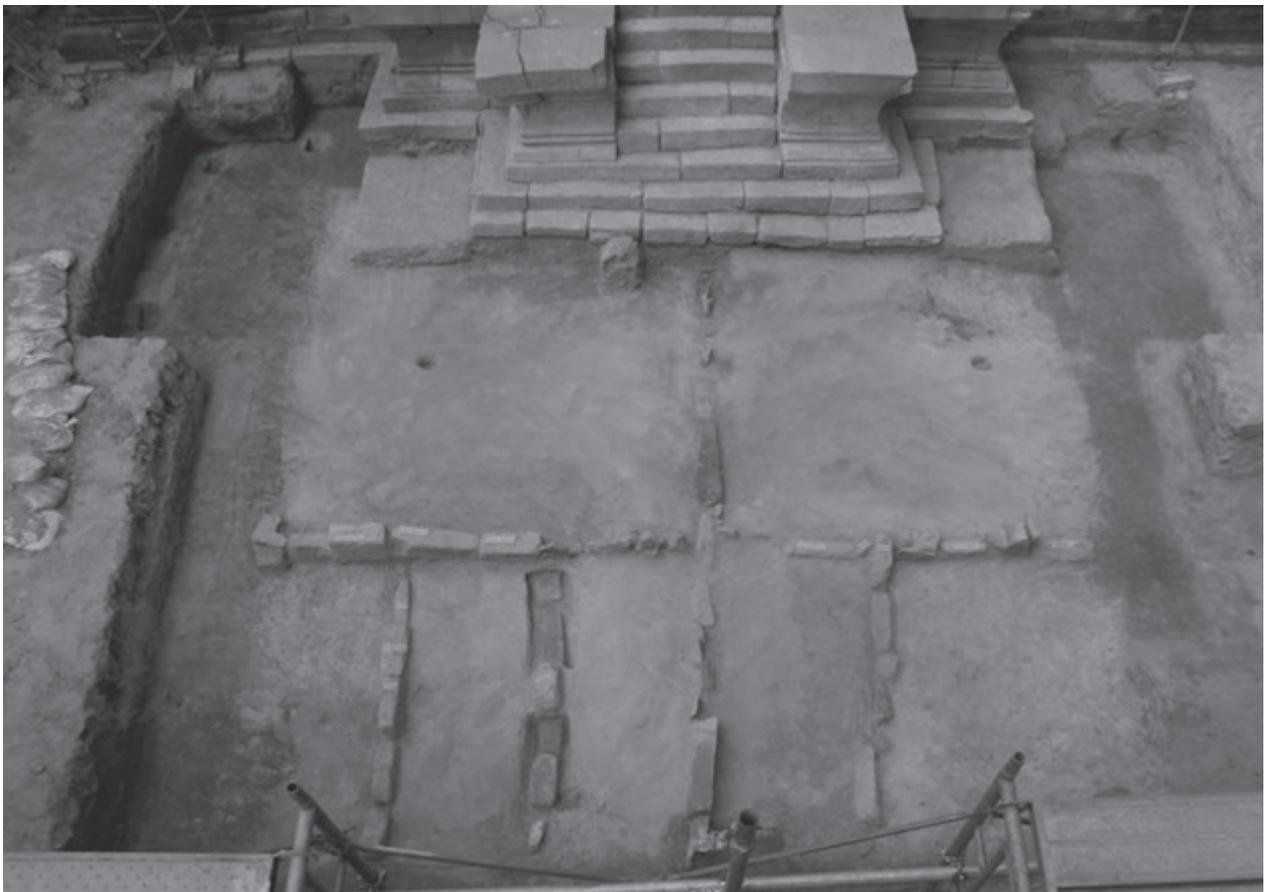
Fig. 53: Digging work and the stone lines in the foundation (viewed from the south)

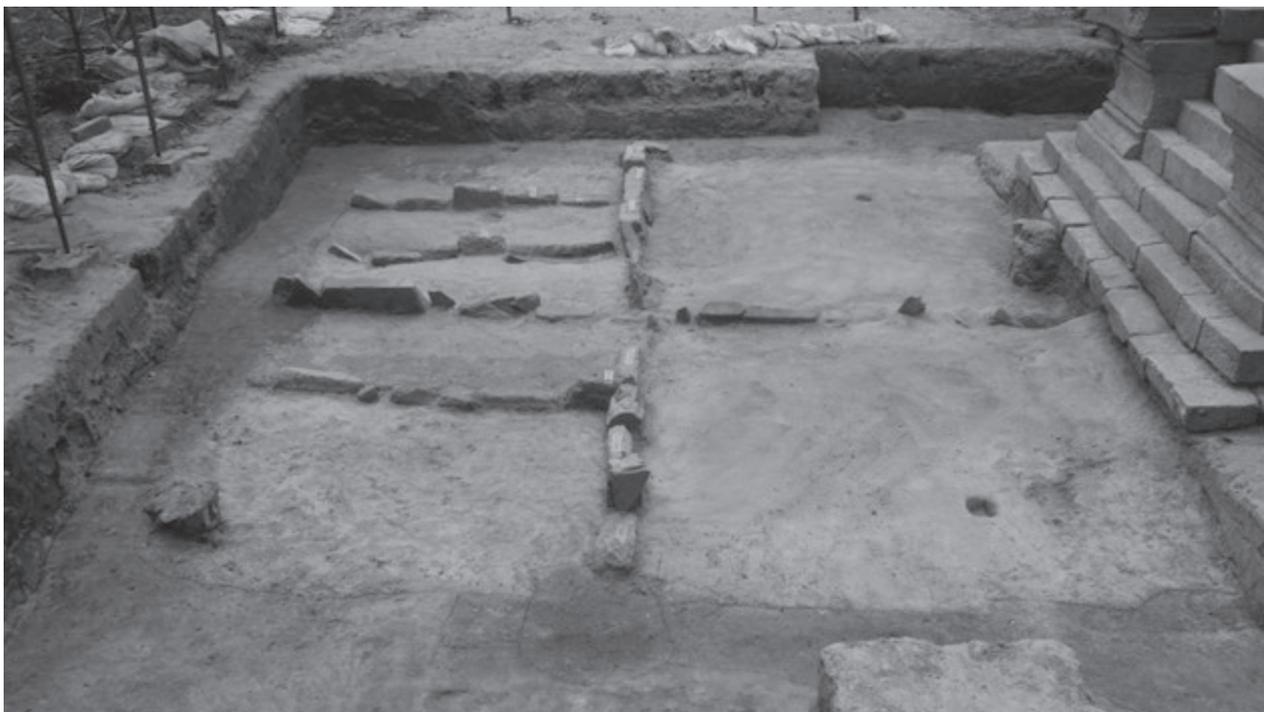
Fig. 54: Digging work and the stone lines in the foundation (viewed from the east)

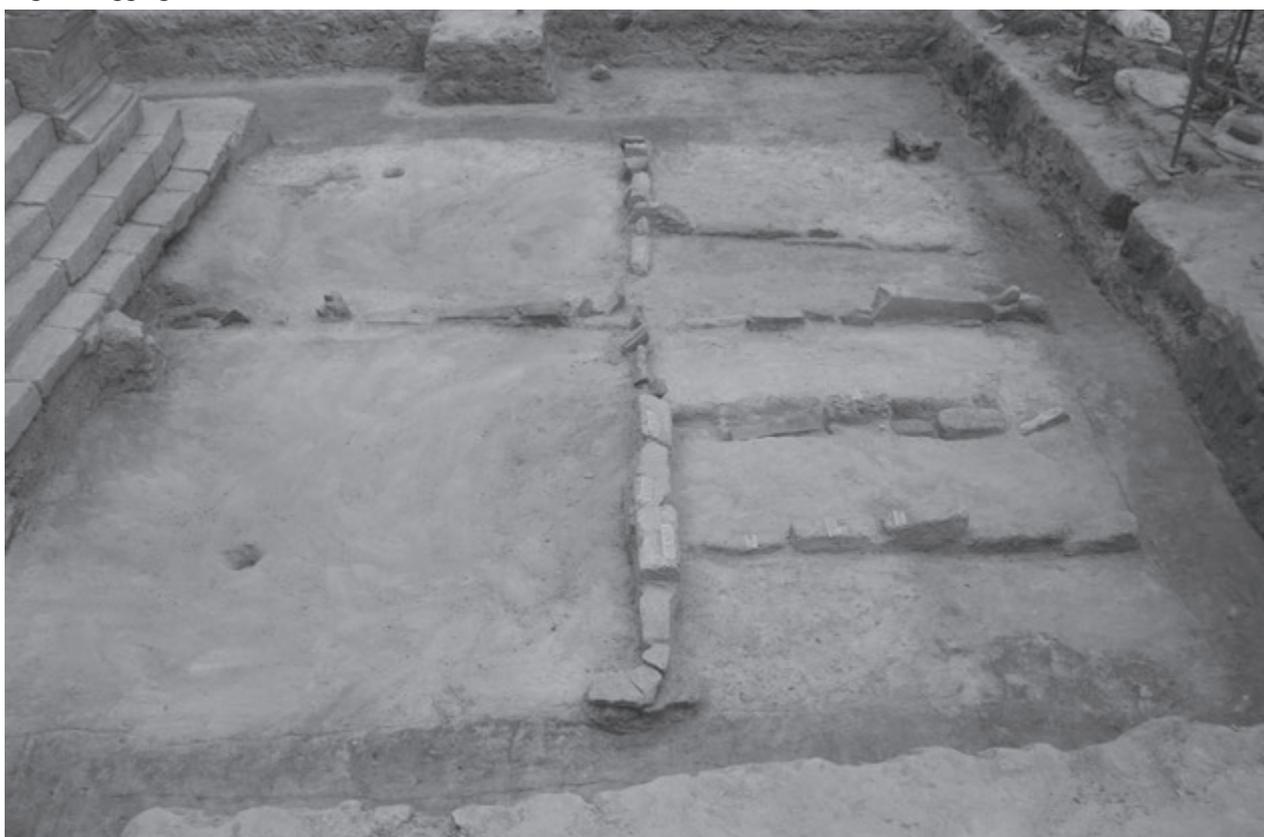
Fig. 55: Digging work and the stone lines in the foundation (viewed from the west)

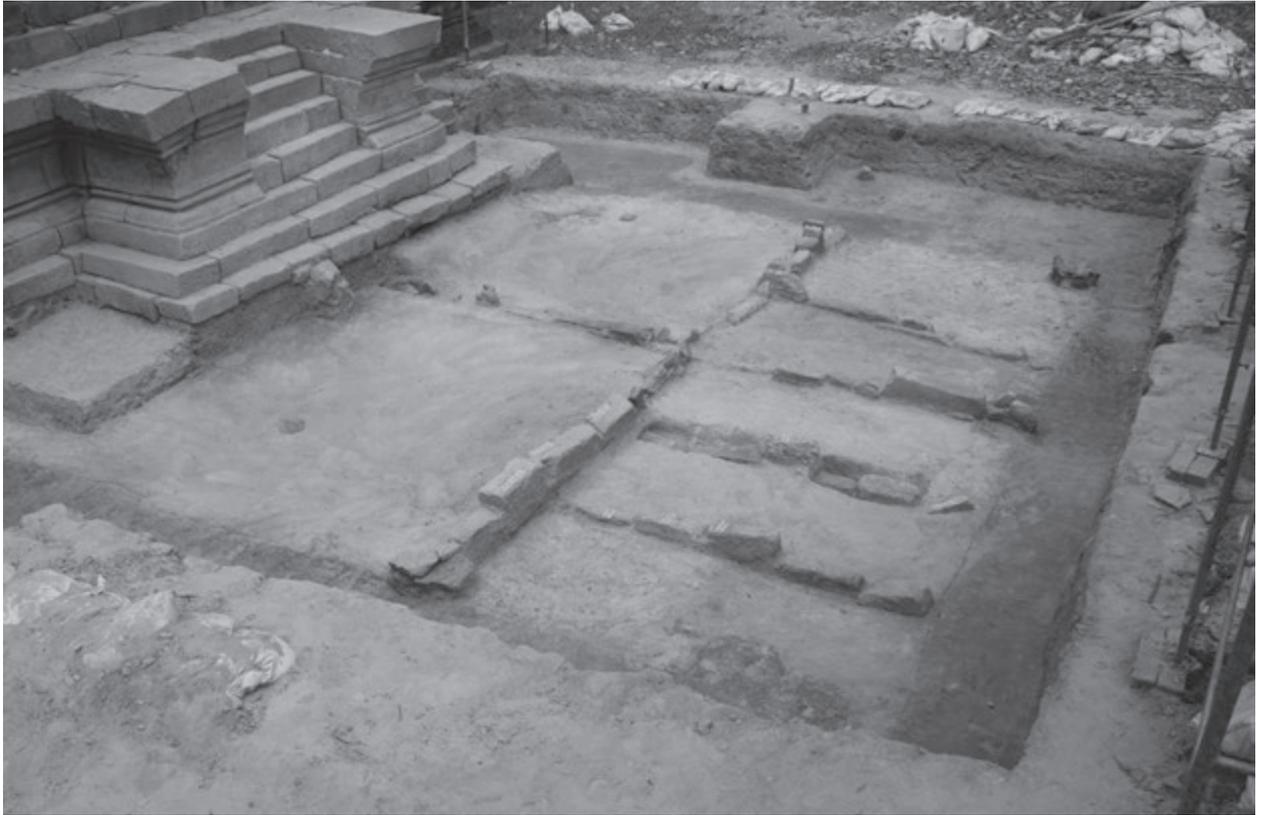
Fig. 56: Digging work and the stone lines in the foundation (viewed from the southwest)

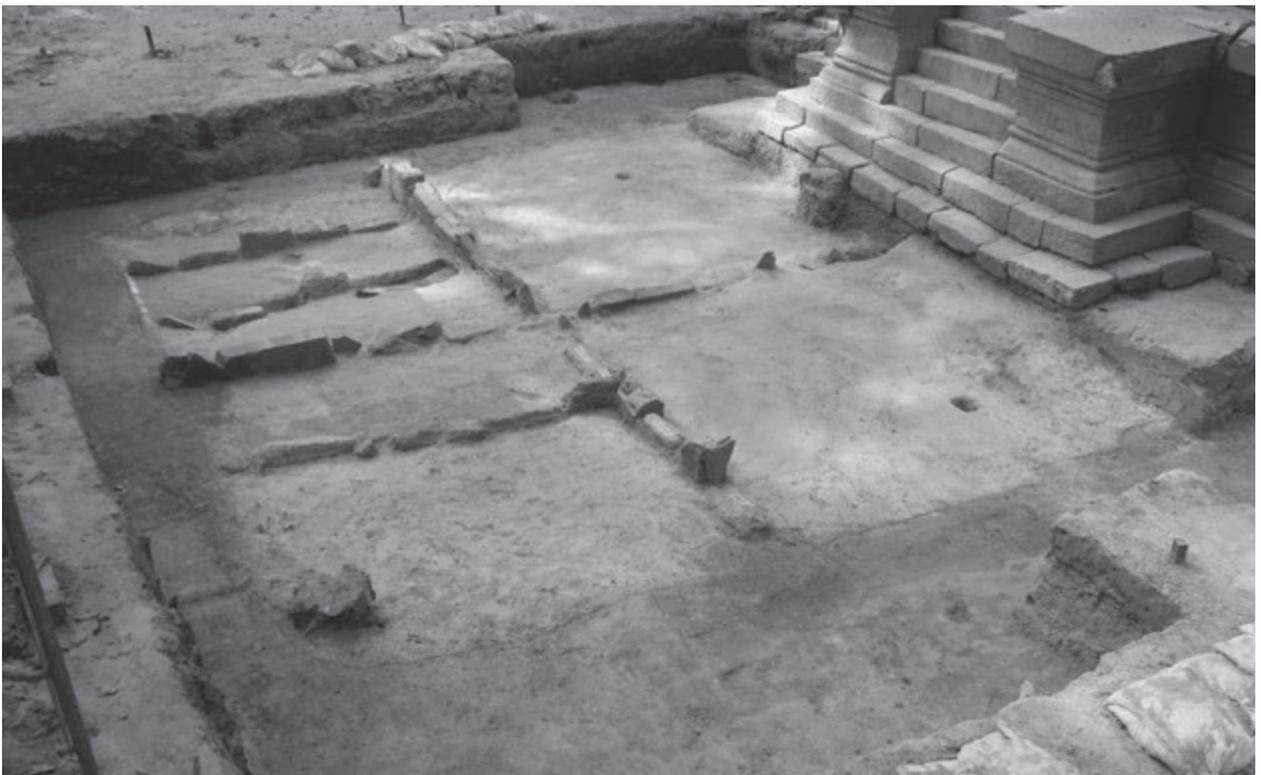
Fig. 57: Digging work and the stone lines in the foundation (viewed from the southeast)

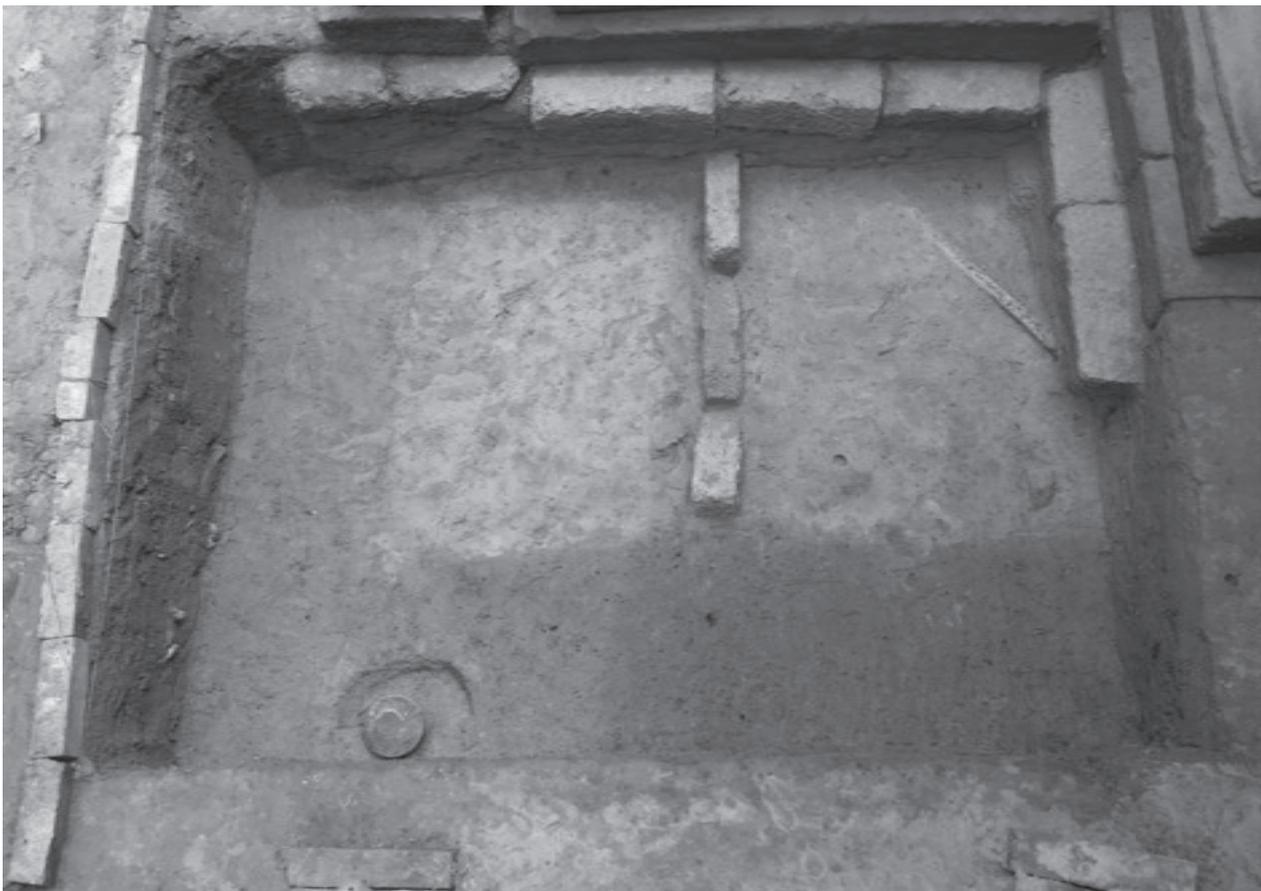
Fig. 58: Southwest corner of the digging work

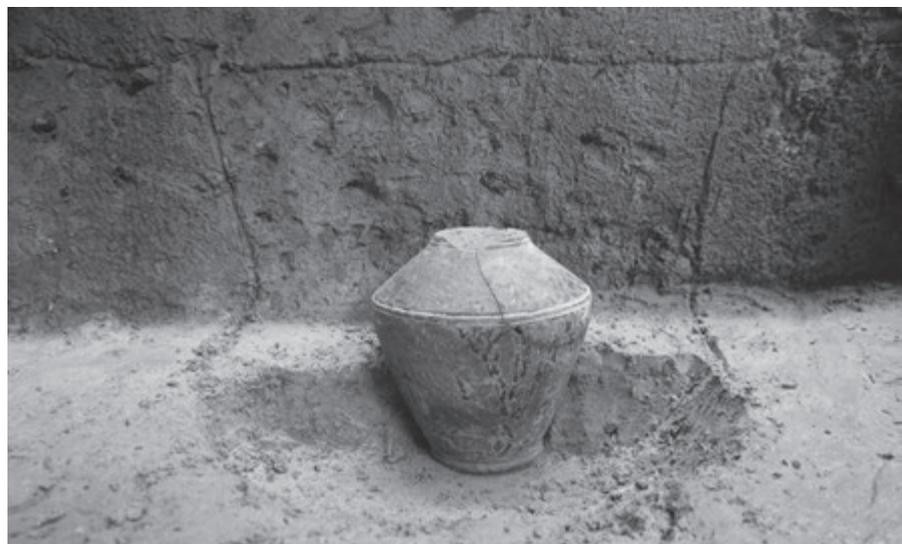
Fig. 59: Buried pottery A excavated state

**Buried pottery A (Fig. 59)** A black-glazed wide-mouthed Jar was excavated from outside the southwest corner of the digging work of the foundation. As shown in Fig. 63, it was installed upright in a recess created in a layer believed to have been the ground surface when the Southern Sanctuary was built. The mouth and neck portions are missing, and are thought to have been destroyed intentionally when burying the pottery. There is black glaze on the shoulder but not on the body, although there are apparent drips from the shoulder. Although no lid was discovered, it was thought to have a wooden lid. As the inside of the pottery was filled with soil, the soil was carefully removed, but all that the Jar contained were a few laterite and sandstone fragments that had probably fallen to the bottom of the Jar.

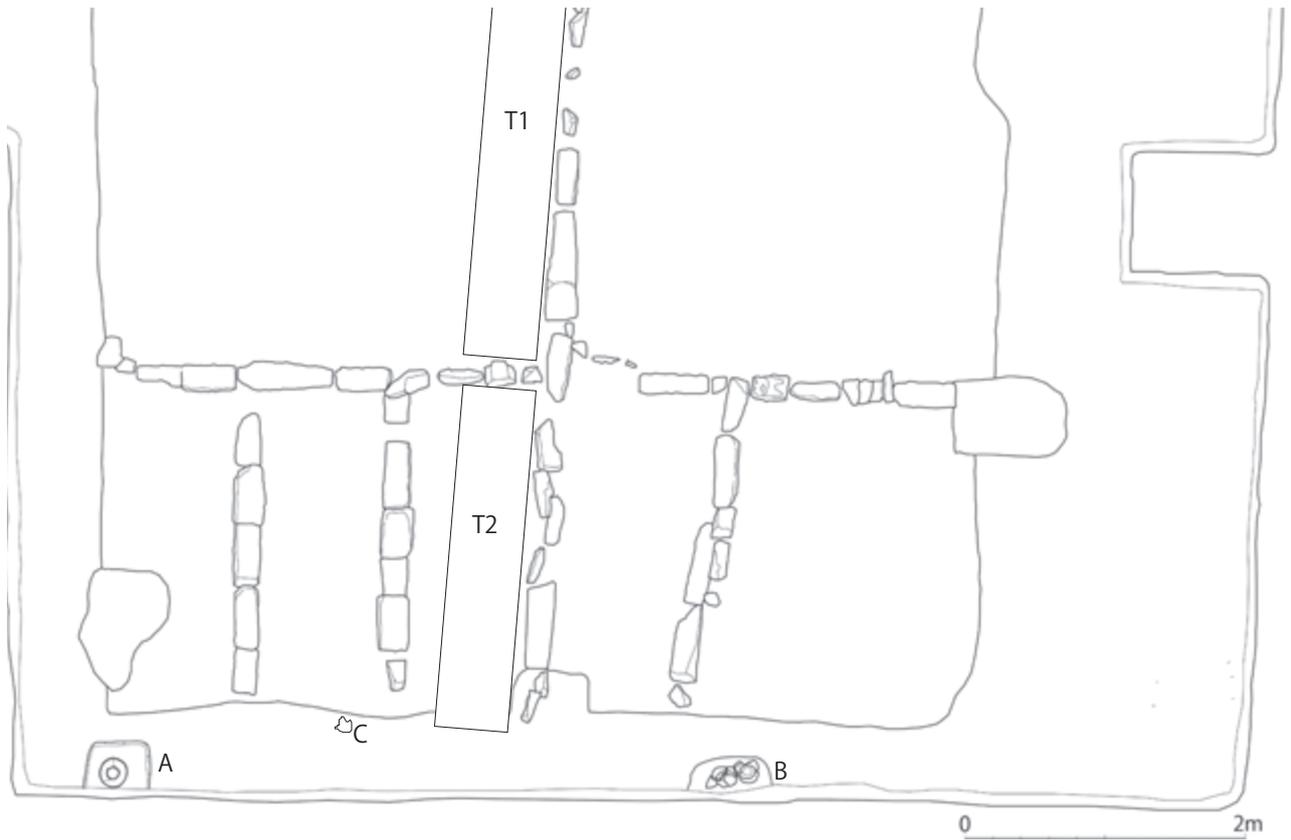
Fig. 60: Buried pottery locations

Four pottery pieces belonging to three pottery remains were discovered. The pottery remains are assumed to have been buried from the outside of the southern digging line of the digging work.

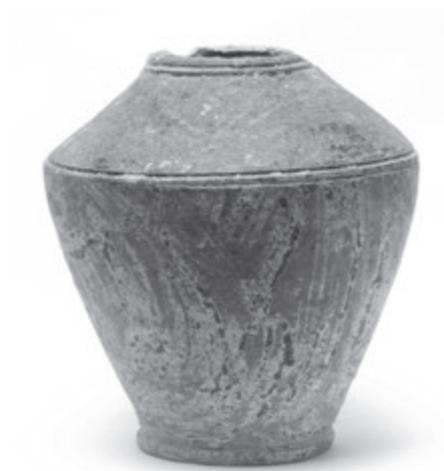
Fig. 61: Buried pottery A photo

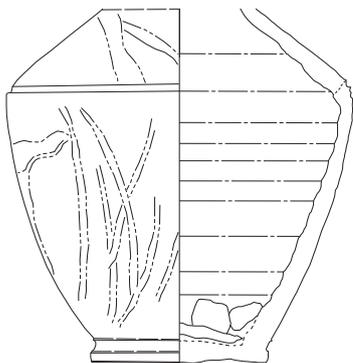
Fig. 62: Buried pottery A drawing

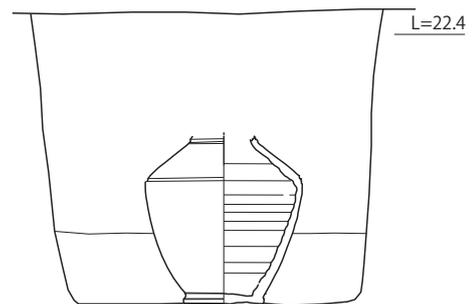
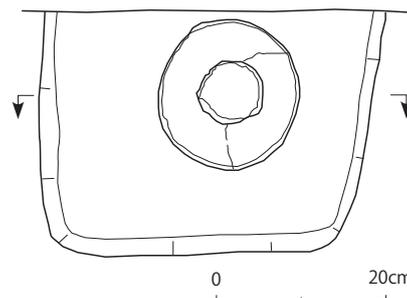
Fig. 63: Buried pottery A drawing of excavated state

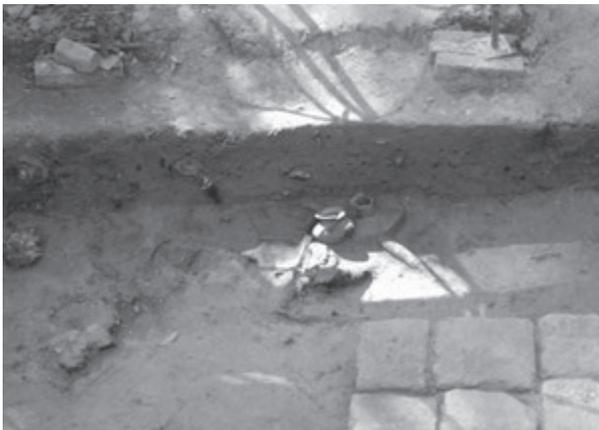
Fig. 64: Buried pottery B excavated state

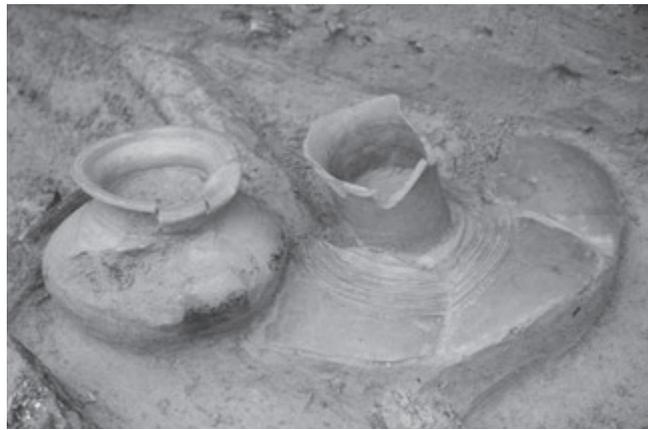
Fig. 65: Buried potteries B excavated condition

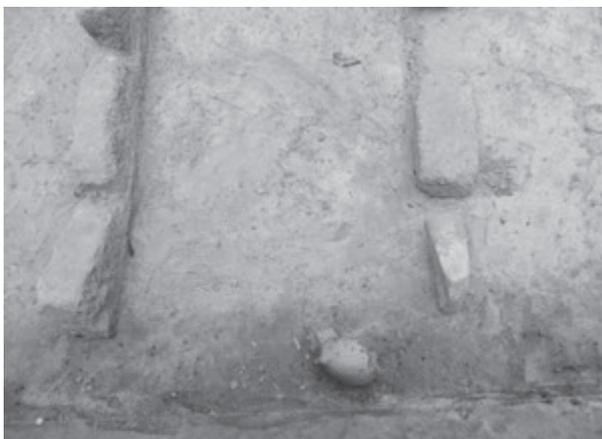
Fig. 66: Buried pottery C excavated state

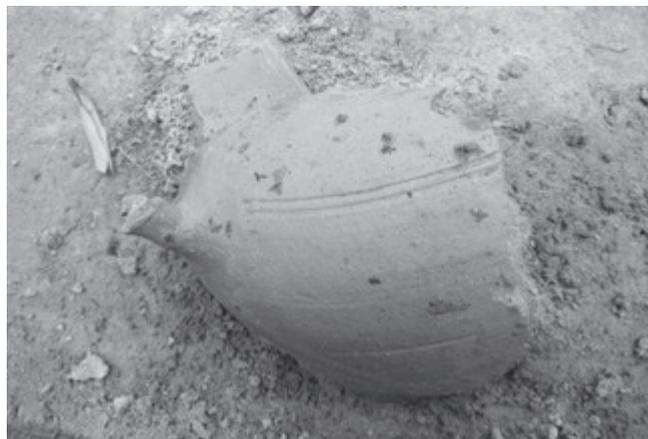
Fig. 67: Buried pottery C excavated condition

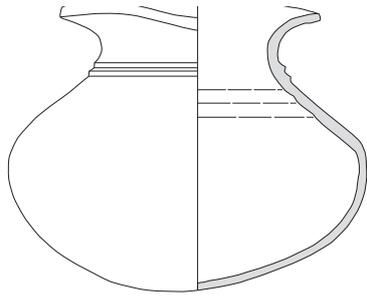
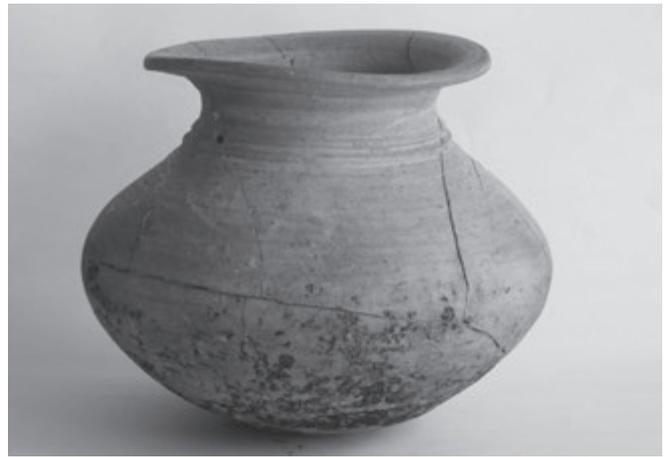
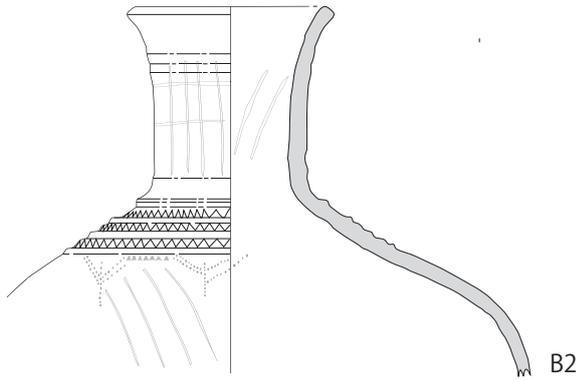
Buried pottery B1 is a round-bottomed Jar. It is 13.6cm in diameter at its mouth, 15.4cm high, and 18.7cm in diameter at the widest part of its body. Unlike regular round-bottomed pots, it rises in a somewhat convex manner above its maximum diameter, and has a shallow, round bottom. There are two grooves around the neck. The rim shows a slight undulation. The clay and firing are both good.

Buried pottery B2 is a long-necked Jar. It has a mouth that is 10.8cm in diameter and a neck that is 9.8cm long. The part below the neck extends widely outward. Roughly one-third of the vase has been found. There are four grooves around the shoulder, with sawtooth patterns carved between the grooves. The part below the grooves is decorated with a zigzag pattern made with long strokes, and between each two zigzag patterns are triangular impressions made with a triangular tool. The outer surface of the body other than the parts with zigzag patterns displays rough linear rubbing marks. The inside of the neck displays marks made when shaping the neck by squeezing. The clay and firing are both good.

Fig. 68: Buried potteries B & C drawings and photo

Buried potteries B (Fig.68,B1,B2) A round-bottomed Jar made of reddish-brown clay resembling earthenware was found in its complete form from the south side of the basement digging ground of the foundation, along with the top half portion of a long-necked vase also made of Haji-type reddish-brown clay.

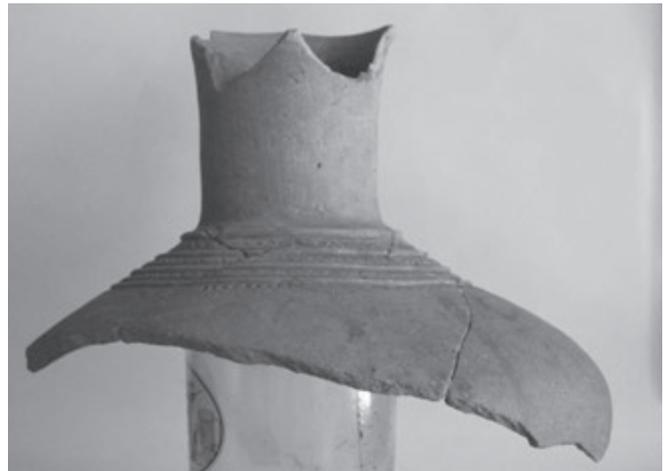
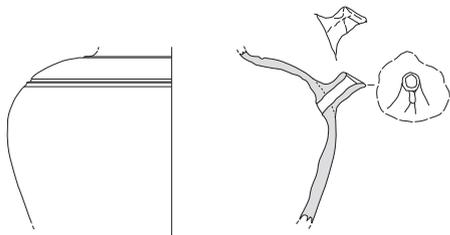
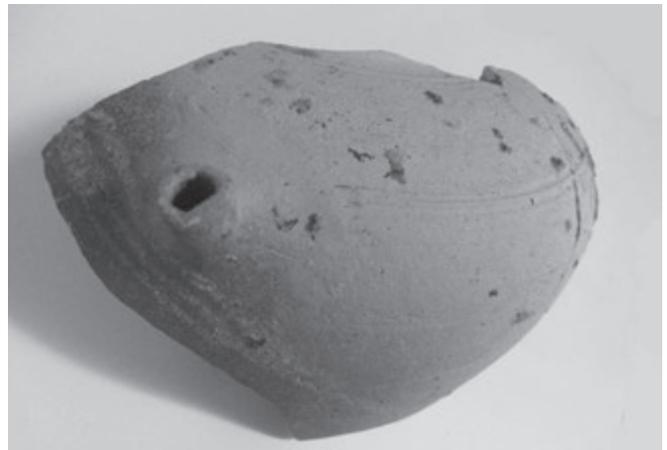
Buried pottery C (Fig.68,C) The kendi is 10.8cm in diameter around the neck and 24.0cm in diameter at the widest part of the body. A spout approximately 4cm in length is attached to the shoulder. There are two deep lines in the horizontal direction around the attachment of the spout. The entire vessel was first shaped, and then a hole was made where the spout is to be attached using a circular rod. Clay was wound around this rod to shape the spout. The clay of this pottery is more refined than that of the above two vessels.

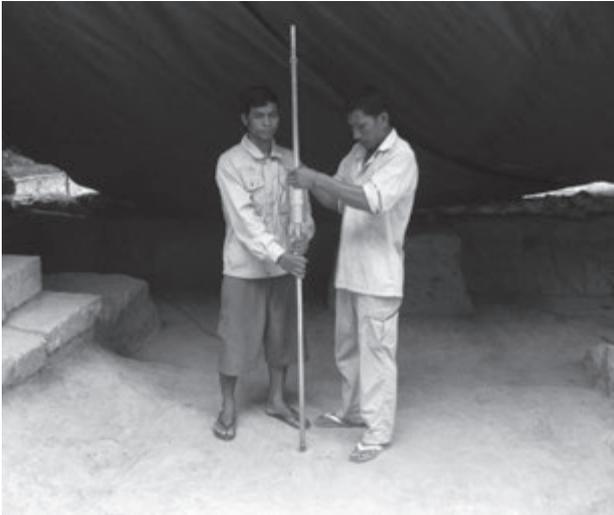
Fig. 69 (top left): Simple penetration test

Prior to reassembly the foundation soil, a ground survey was conducted around the stone lines in the foundation. On June 10 and 11, 2014, a simple penetration test, permeability test and a boring test using a hand auger were performed in two locations at the stone lines. Results of the tests are provided in a separate ground survey report.

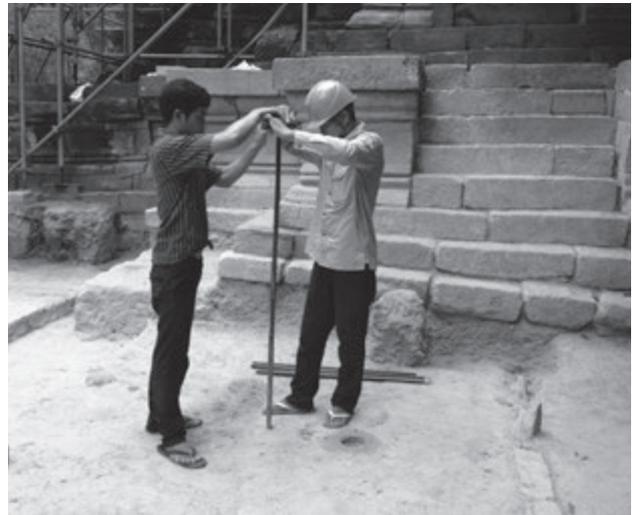
Fig. 70 (top right): Hand auger test

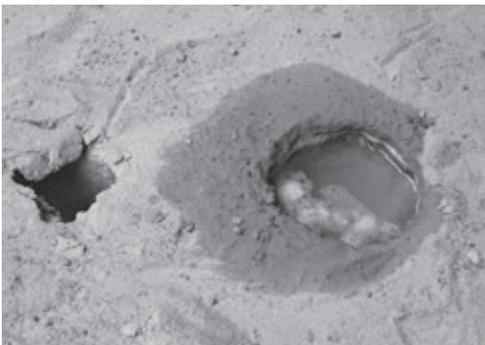
Fig. 71 (left): Permeability test

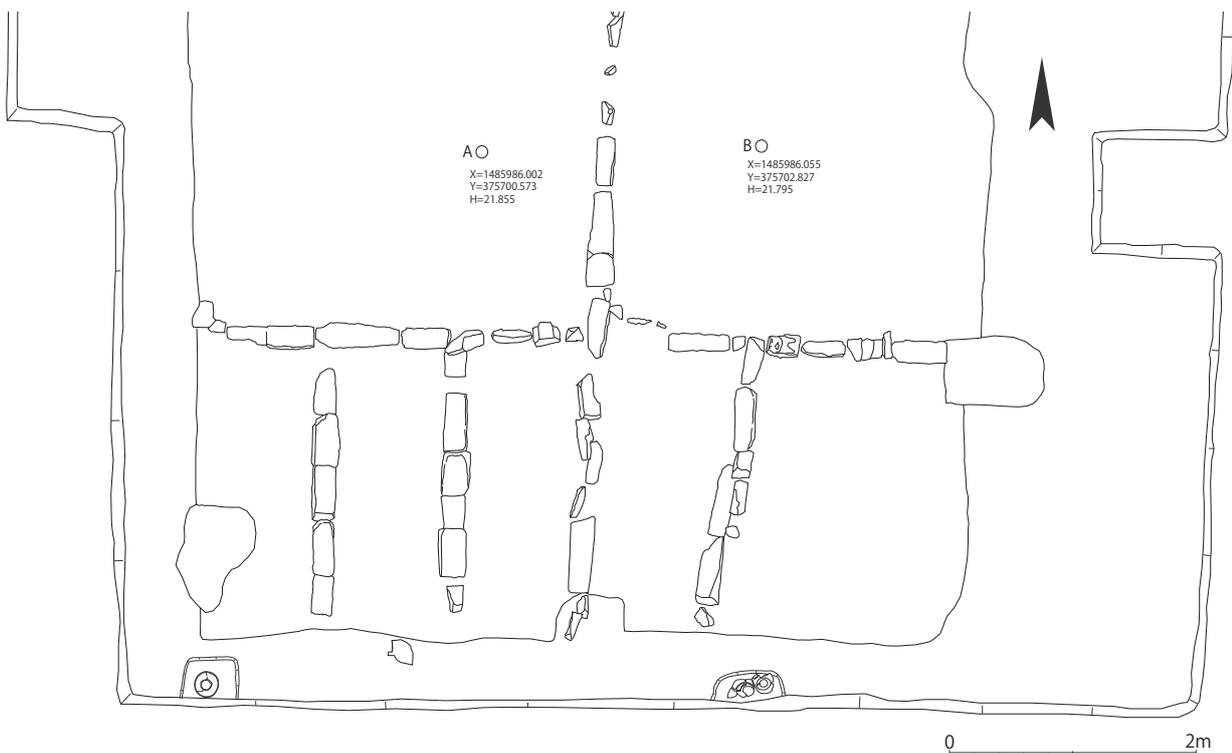
Fig. 72: Ground survey locations
