*World Cultural Heritage*

**Nara Palace Site**  
**East Palace**  
**Garden**

平城宮  
東院庭園

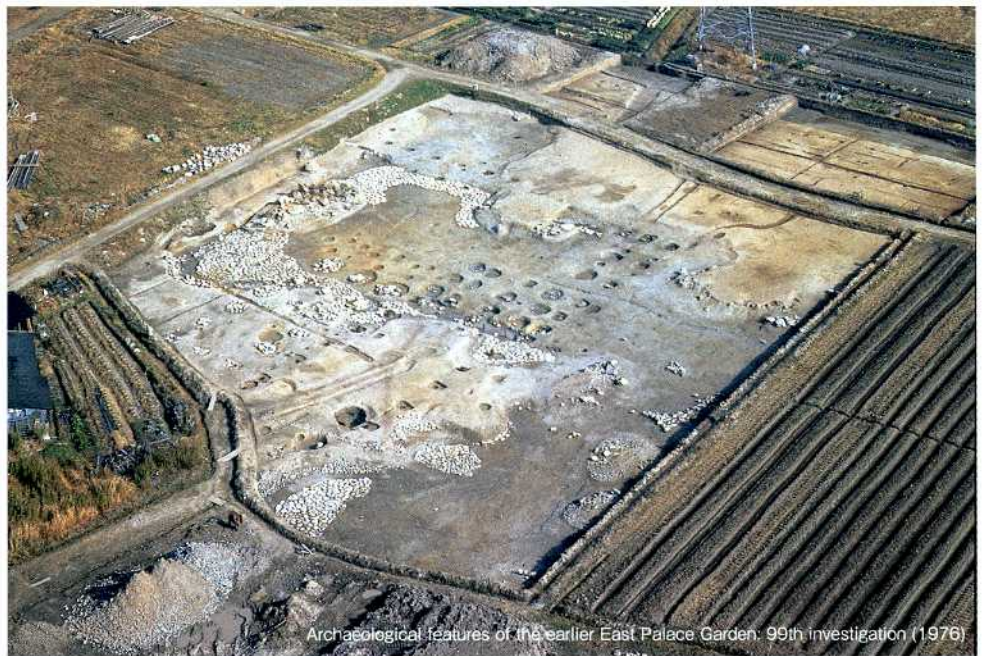
Archaeological features of the earlier East Palace Garden: 99th investigation (1976)

The pond at the East Palace Garden can be divided into two phases, an earlier and a latter one, by substantial modification in the later Nara period. In the earlier phase, large round stones were laid on the bottom forming a belt running along the shore, but the latter phase saw a shallow pond entirely paved with a layer of small stones extending onto the banks. The shape of the pond also changed from the relatively simple backward "L" of the former phase to complex one with inlets, island, and peninsulas, and a stone arrangement forming an artificial hill on the north shore was also newly added in the latter phase. Along with this reconfiguring of the pond, the buildings were replaced several times.

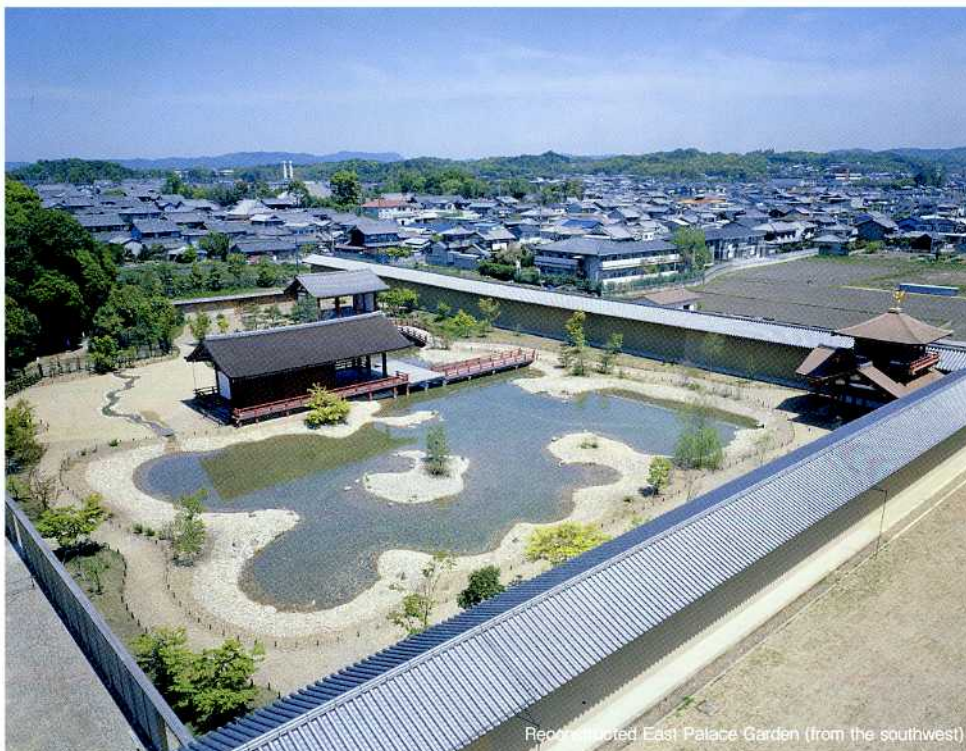
Reconstructed East Palace Garden (from the southwest)

In the East Palace Garden, there are restored buildings belonging to the later Nara period in the west side of the pond and the northeastern and southeastern parts of the site. These buildings are as follows (see the picture left); the central building in the middle left, the northwest building above it, and the two-stories corner tower in the right side of the middle part. Moreover, other features of the buildings belonging to different phases in the Nara period have been unearthed, which have not been reconstructed. For example, there were one building with pillars atop foundation stones in the north of the central building and another building with eaves on its north side in the north of the southwestern part of the pond. Both of them were facing to the pond. Features of winding stone-lined ditch for "Kyokusui" (stream) were unearthed at two locations. These are considered to have been associated with the pond in the earlier phase; however, the one located in the west of the central building was restored.

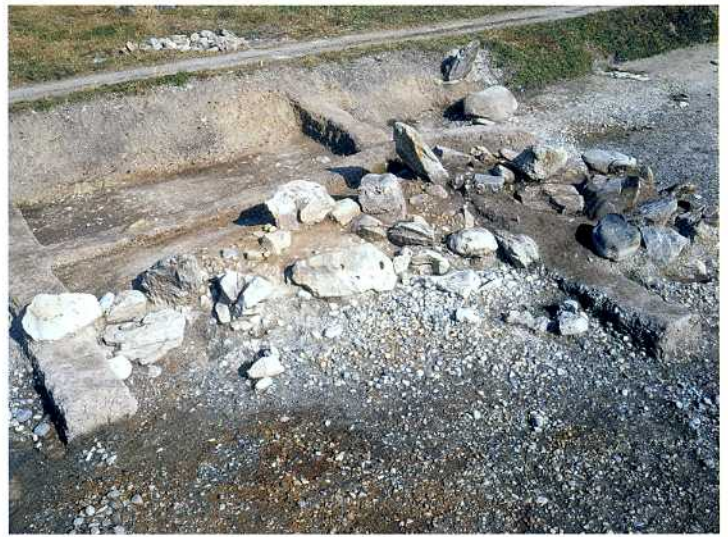
▲ Vicinity of the artificial hill stone arrangement on the north shore, latter phase pond features (from the southwest)

\* An artificial hill (tsukiyama) is a man-made feature in the shape of a mountain placed within a garden to create a hill and water landscape, and in former times it was also called *kazan*. The construction of such *kazan* with piled stones is known to have been practiced in China by the time of the Later Han Dynasty. In Japan, this is the oldest example.

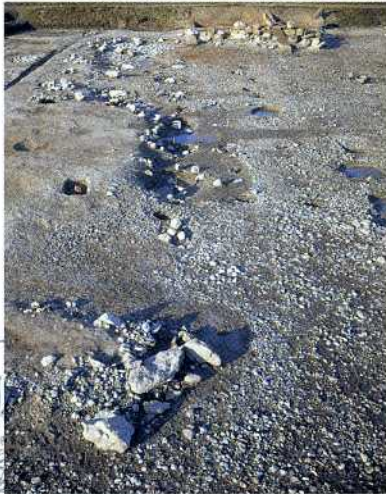
◀ Western coast of the pond in the latter East Palace Garden (99<sup>th</sup> investigation; from the south)

Rocks were arranged in the point of the peninsular and pebbles were scattered on the bottom of the pond.
