World Cultural Heritage

Nara Palace Site
East Palace
Garden

平城宮
東院庭園

The East Palace Garden pond: Earlier and latter phases

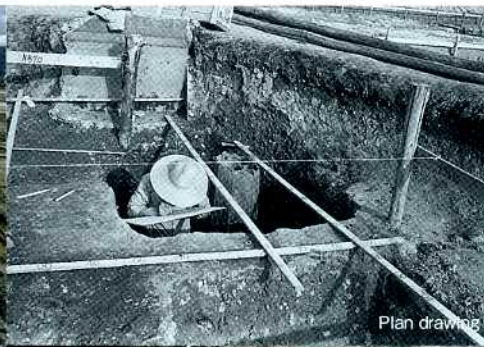
Plan drawing
