World Cultural Heritage

Nara Palace Site
East Palace
Garden

Nara National Research Institute for Cultural Properties

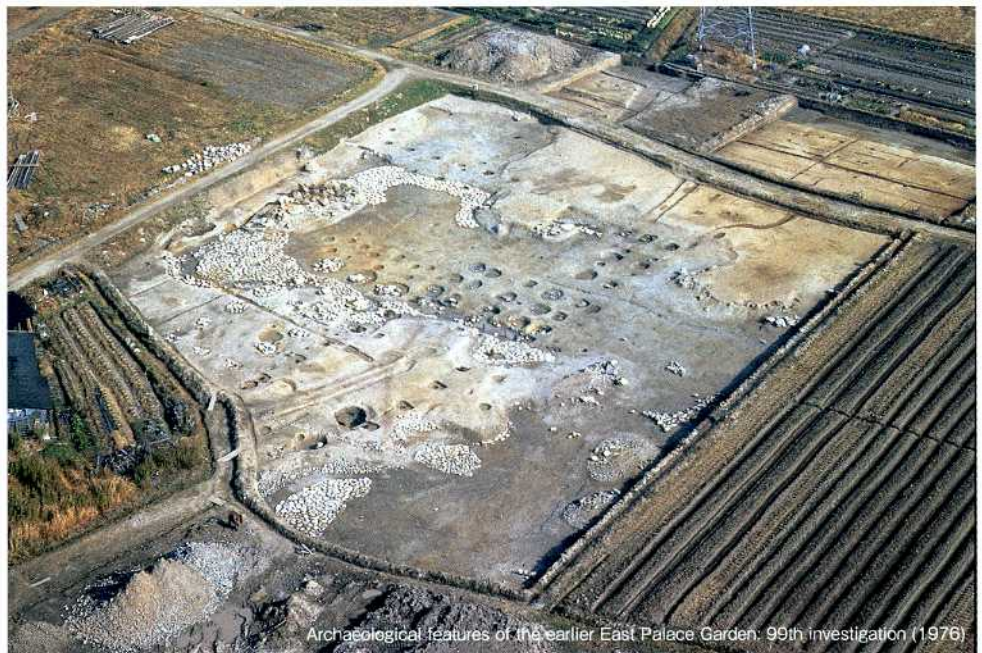
Archaeological features of the earlier East Palace Garden: 99th investigation (1976)

The pond at the East Palace Garden can be divided into two phases, an earlier and a latter one, by substantial modification in the later Nara period. In the earlier phase, large round stones were laid on the bottom forming a belt running along the shore, but the latter phase saw a shallow pond entirely paved with a layer of small stones extending onto the banks. The shape of the pond also changed from the relatively simple backward "L" of the former phase to complex one with inlets, island, and peninsulas, and a stone arrangement forming an artificial hill on the north shore was also newly added in the latter phase. Along with this reconfiguring of the pond, the buildings were replaced several times.

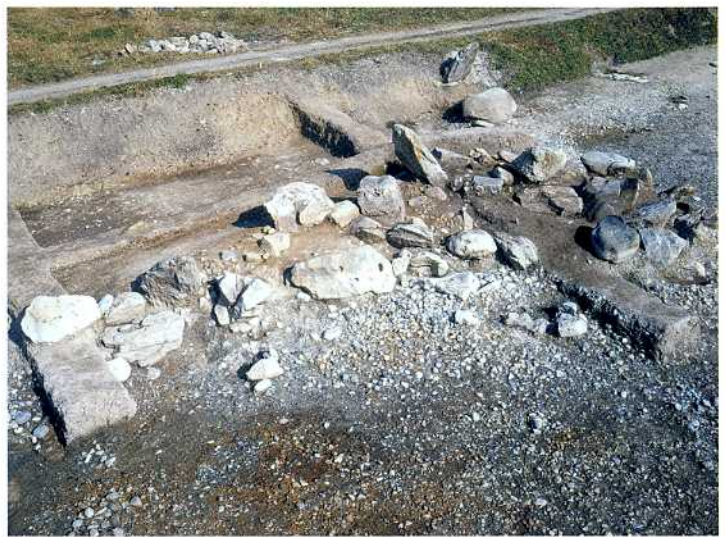
▲ Vicinity of the artificial hill stone arrangement on the north shore, latter phase pond features (from the southwest)

* An artificial hill (tsukiyama) is a man-made feature in the shape of a mountain placed within a garden to create a hill and water landscape, and in former times it was also called *kazan*. The construction of such *kazan* with piled stones is known to have been practiced in China by the time of the Later Han Dynasty. In Japan, this is the oldest example.

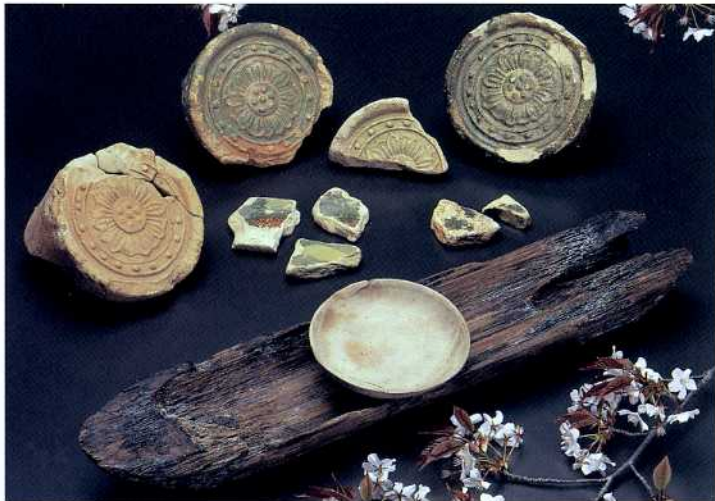
▲ Artifacts recovered from the pond
Glazed tiles and a wooden small vessel with pottery used for banquet

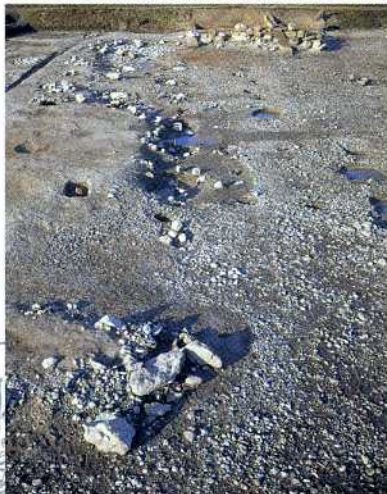
◀ Western coast of the pond in the latter East Palace Garden (99th investigation; from the south)

Rocks were arranged in the point of the peninsula and pebbles were scattered on the bottom of the pond.

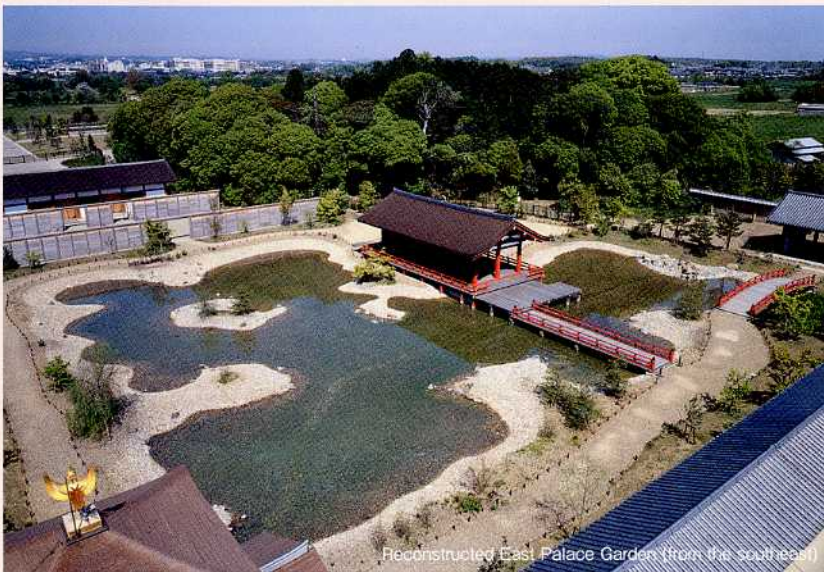
Reconstructed East Palace Garden (from the southeast)

The composition of the East Palace Garden centers on a pond, 60 m east-west by 60 m north-south, appearing as a backward “L” when viewed from the south. The central building standing on the west bank has an open platform extending over the water, from which a bridge connects to the east bank. At the pond’s northern edge is a stone arrangement forming an artificial hill, and in the southwestern part is an island, each serving as a scenic focus of the garden, and ornamental stones were placed at the tips of the inward jutting peninsulas. The pebble beach, made of small stones laid over a gentle slope extending from the bottom of the pond onto its banks, traces out a winding shoreline, bringing to mind the air of an elegant garden of the Nara period. This important site may be called the precursor of Japanese gardens that from the Heian period on made natural scenery the main element.

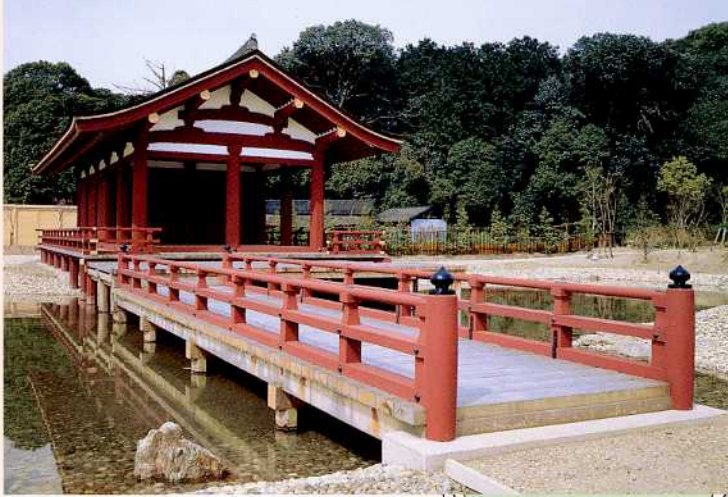
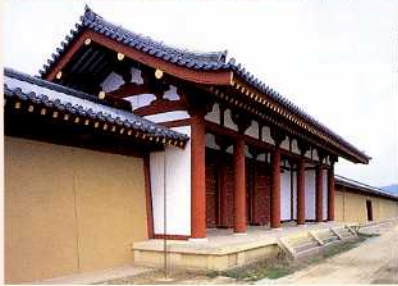
▼ Central building and bridge (from the east)

The central building was the East Palace Garden's "main hall" located at the center of the pond's west bank, and is thought to have been the focus of occasions when banquets and ceremonies were held. It was furnished with an open platform extending over the water, from which a flat bridge connected to the east bank. The bridge was long in the east-west direction, standing on embedded pillars that made four bays down its length and one bay in width. The pillars have been reconstructed as octagonal in shape (24 cm diameter), modeled after the recovered remnants of veranda struts of the central building. Deck boards were shaped after referring to the drawing of *Shigisan Engi Emaki*. Also, the onion-bull jewel ornaments on the end pillars of the flat and arched bridges are based on tile examples of the same item, recovered in 1966 from the southeast corner of Nara Palace.

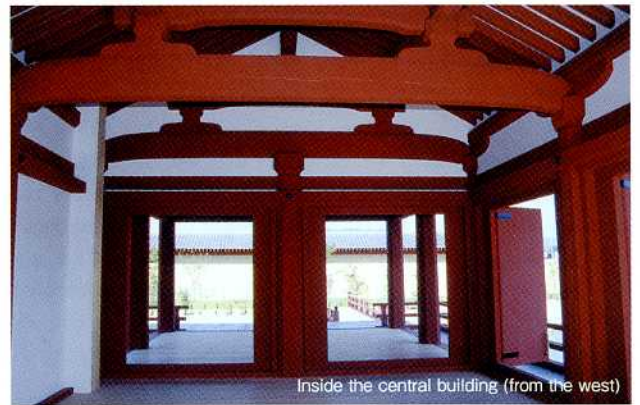
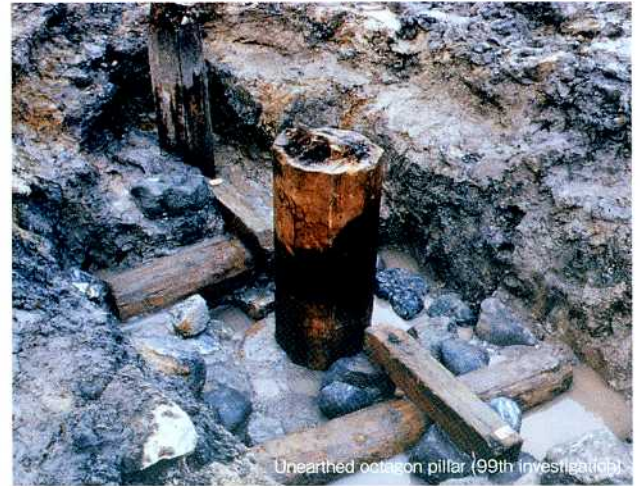
· Central Building

This is an east-west oriented structure with a core of five bays down the length and two bays in width, encircled on four sides with a veranda. Most of the pillars stood on foundation stones, with those of the four corners only being embedded in deep postholes. As the ground had been specially strengthened for the western three bays alone, that portion is thought to have been closed off as a room, with the eastern two bays being an open hall connecting onto the pond (see picture upper right). Also, as the layout is highly similar to the earlier form of the Denpōdō at Hōryūji temple, the dimensions of the members and the structural form in principle took that building as model for the reconstruction. Further, as the pillar remnant in the southeast corner was made with wide bevels produced by cutting away the four edges of a square post, after referring to the Phoenix Hall of Byōdōin and other surviving ancient buildings that utilized beveled members, beveling was applied to nearly all parts of the structure.

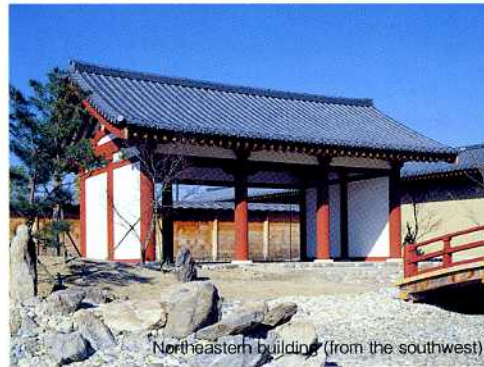
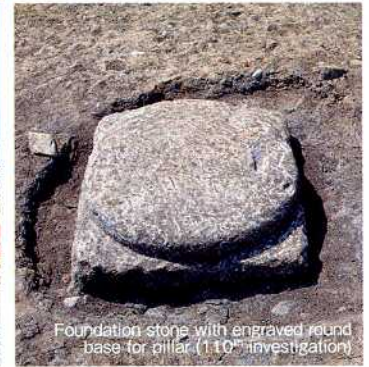
· Northeastern Building

This is an east-west oriented structure with three bays down the length and two bays in width, with pillars atop foundation stones. A foundation stone with engraved round base for the pillar was unearthed. From this evidence, we inferred that the diameter of the pillar measured 41.4 cm. The reconstruction was referred to the Dining Hall of the Hōryūji temple in the structure and size. This building is supposed to have been a facility like a bower located in the north of the pond. Therefore, we restored this building as an open structure with walls only on the east and west sides and no wall on the north and south sides.

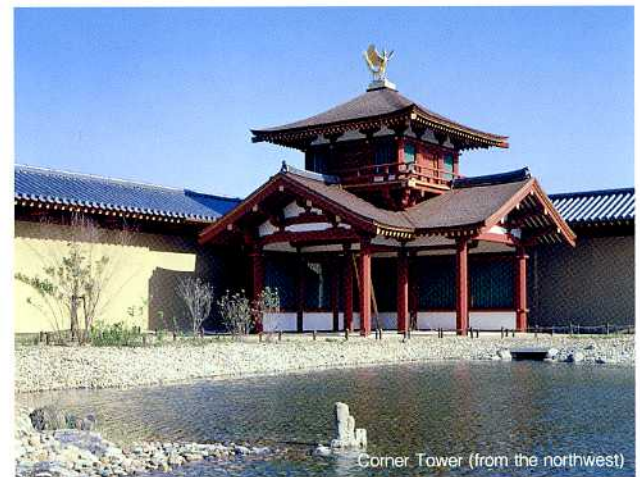
· Corner Tower

This is a two-story structure located in the southwest of the pond. Excavation revealed that there was an east-west building three bays long by two bays wide, with a north-south building two bays long by one bay wide, attached to the north side and set along the east side of the east-west building. Remains of pillars octagonal in section (ca. 34 cm in diameter) were unearthed, with foundation boards made by stones and woods placed underneath the pillars. In addition, the pillars had brackets at the position of ca. 30 cm from its bottom, and the brackets were placed on the pillars intersecting at the right angle. Since the foundation was specially strengthened, we consider that this was two-story building. Therefore, the building was restored as the structure three bays long by two bays wide with the northern attached building two bays long by one bay wide, with gable roofs covered by cypress bark for the first tier, with a square structure three bays on the side with a pyramidal roof covered by cypress bark, after referring to the corner towers of the Byōdōin temple.

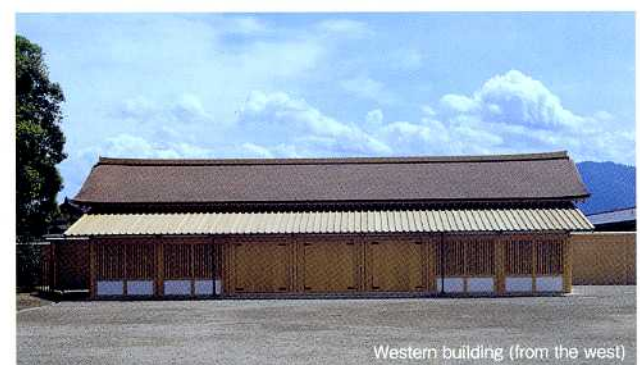
Reconstruction and utilization of the Western Building

This is a north-south gabled building seven bays long by two bays wide, with a roofed veranda on the western side, with a function for public guidance. Appearing as a waiting room set up at the side of the road connecting the Jeweled Hall to the East Palace South Gate, originally it was not a garden-related facility. But in the reconstruction program it was readied as an entrance leading into the garden from the parking lot on the west, and as a management facility. While the outer structure was reconstructed as an ancient building, new materials such as steel beams and glass were abundantly used for the interior, a device which enables the reconstructed portions and the space used for modern functions to be distinguished at a glance.
