Chapter 2: Outline of the Survey and Restoration Project of the Central Sanctuary

Section 1: Progress of the reassembly of the central sanctuary

Section 2: Return of decorative stone materials from Conservation d'Angkor

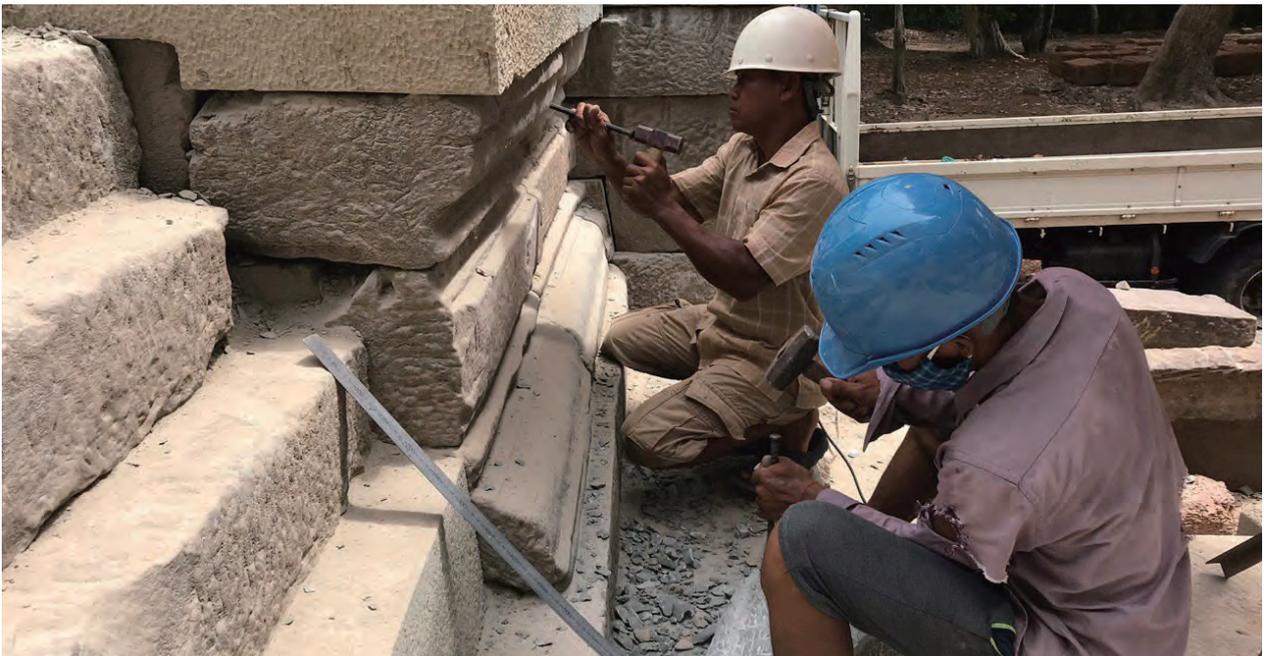
Fig. 24 Curving the new stone blocks for the central sanctuary

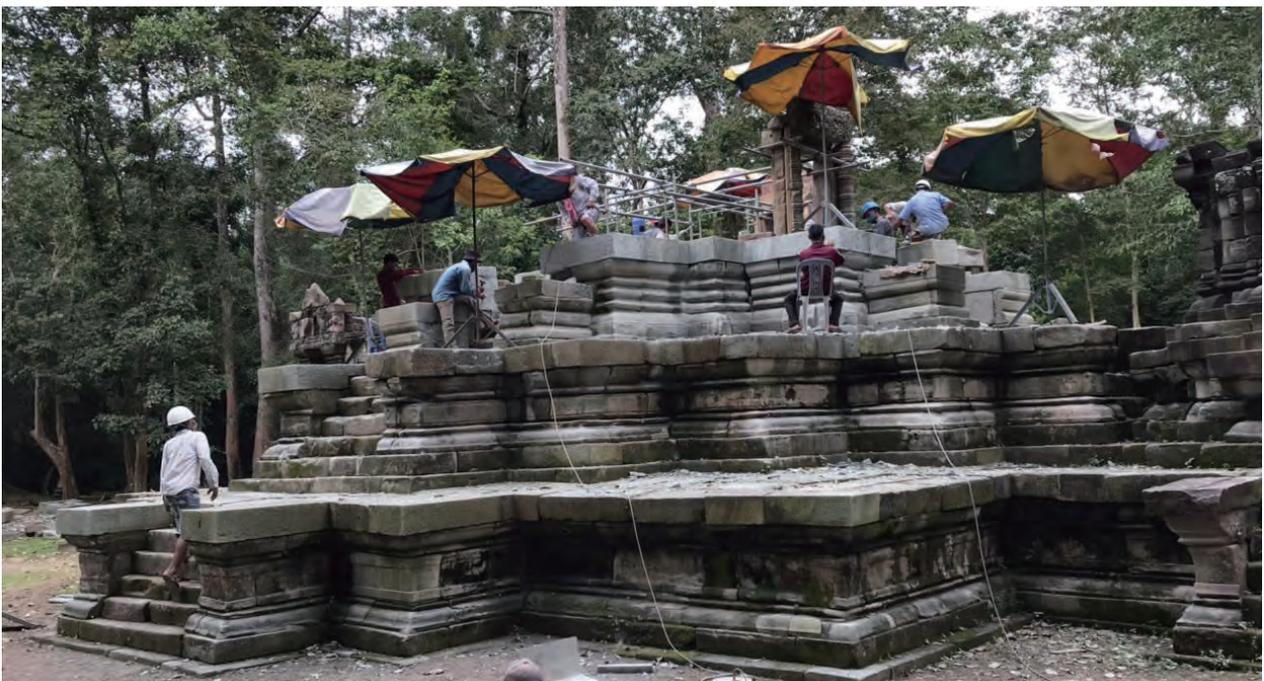
Fig. 25 View of the reassembly work of the central sanctuary

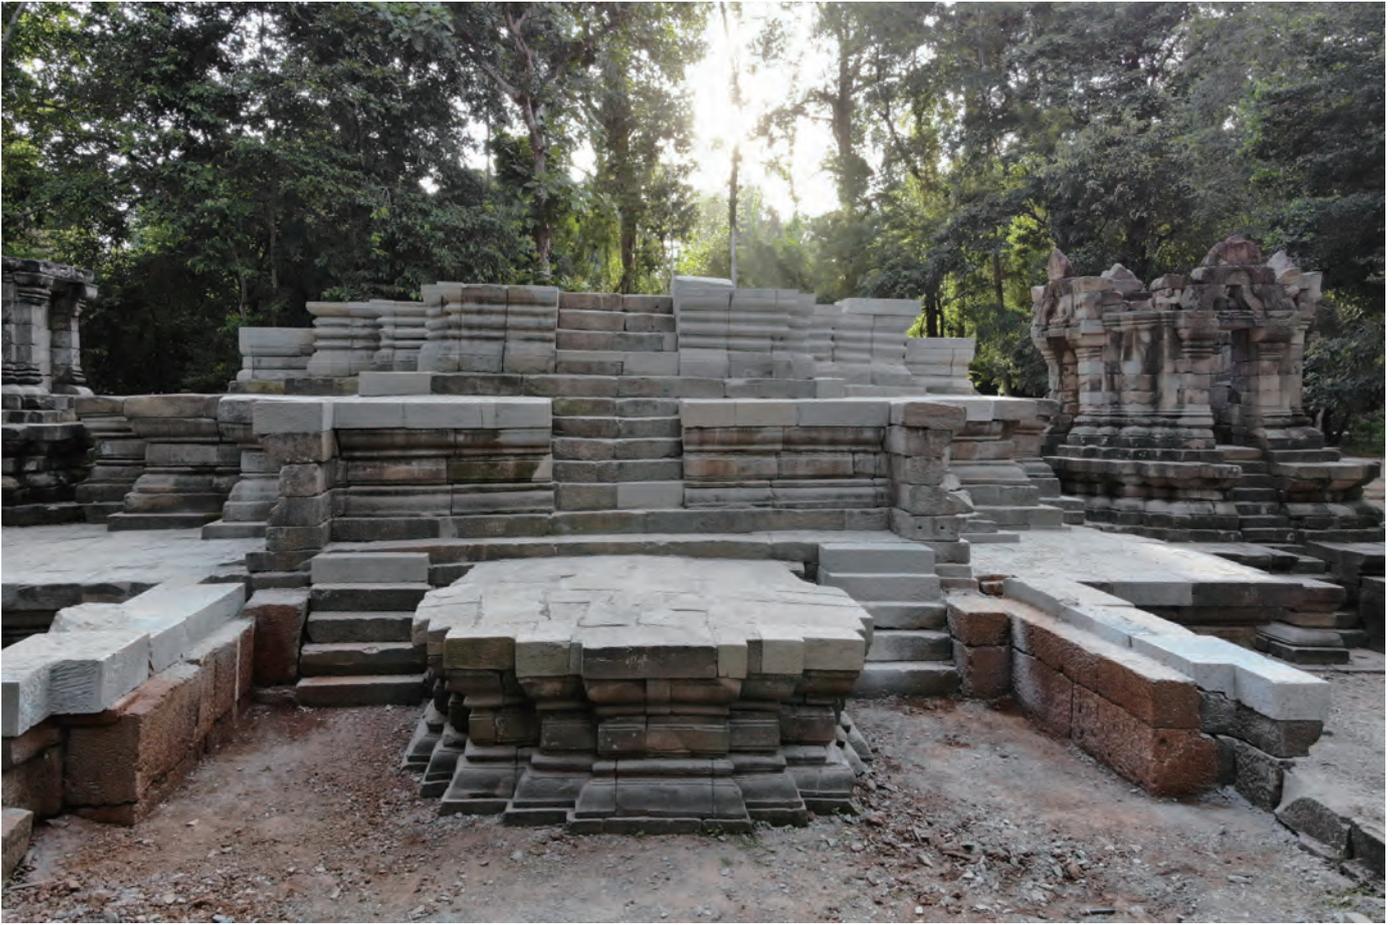
Fig. 26 View of the reassembled platform of the central sanctuary (view from the east)

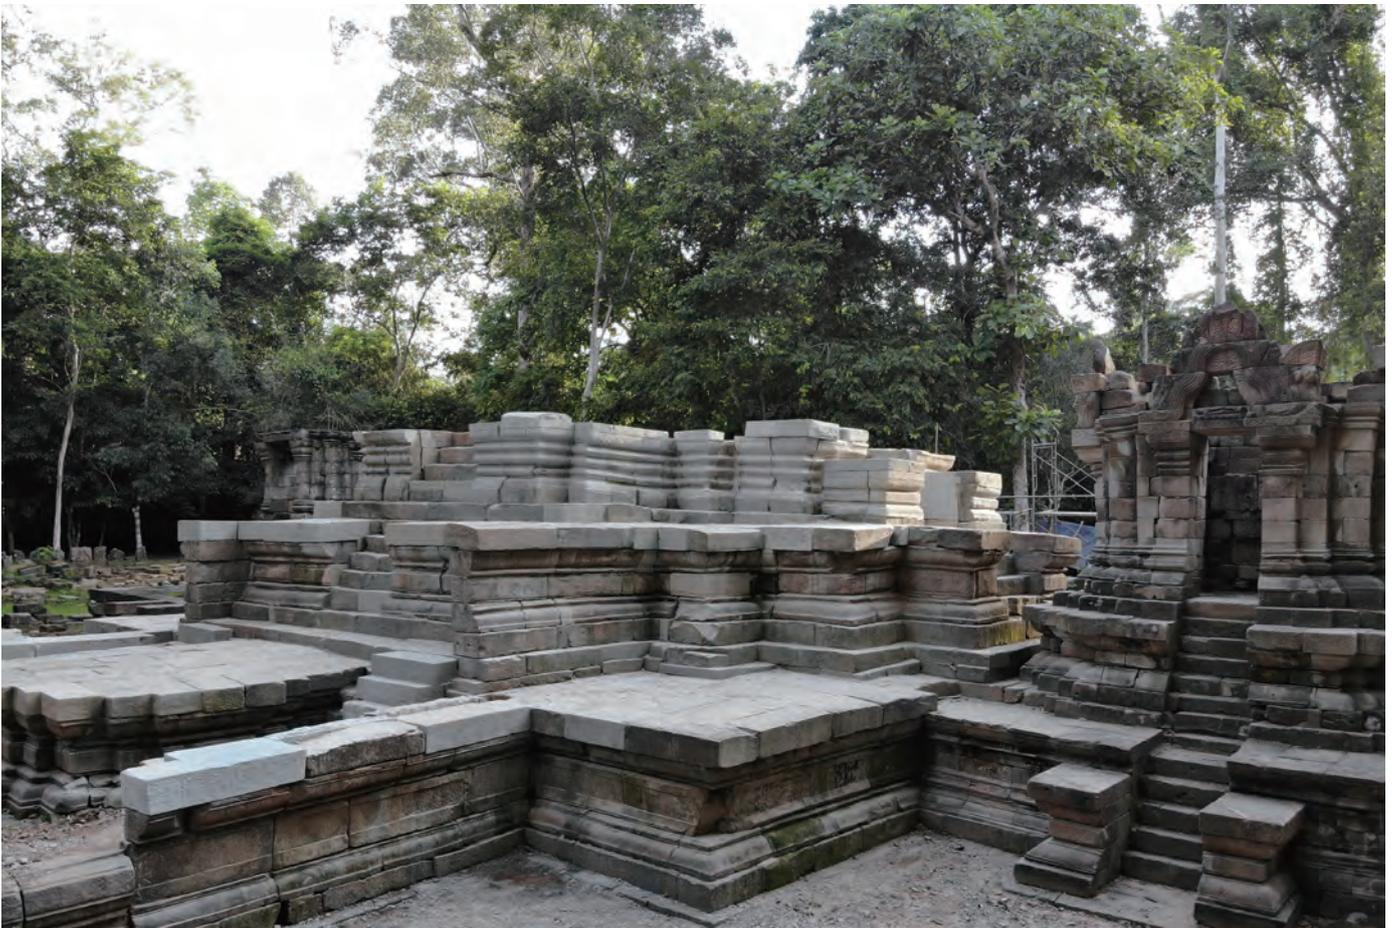
Fig. 27 View of the reassembled platform of the central sanctuary (view from the northeast)

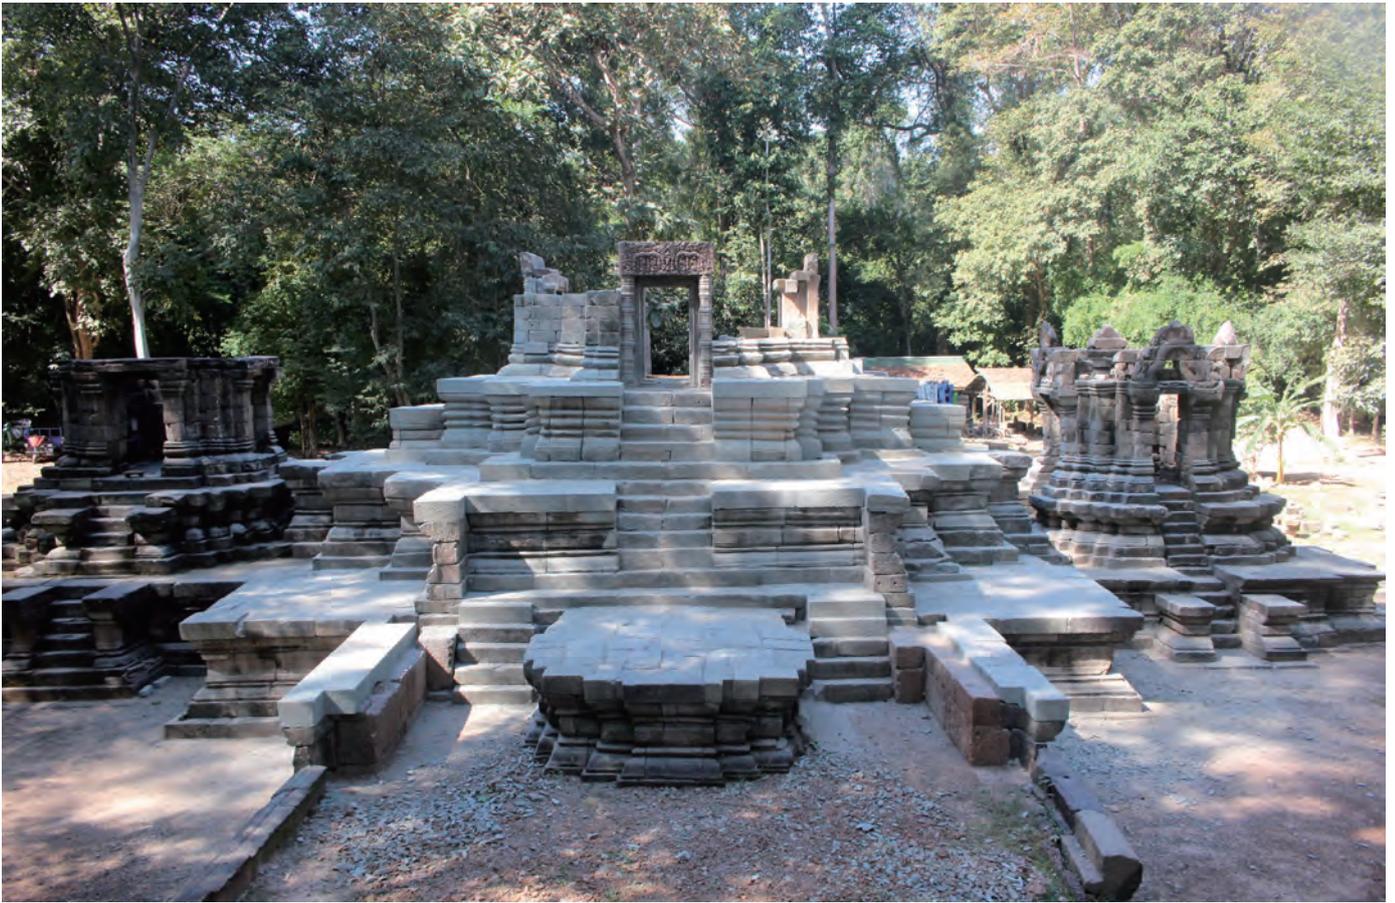
Fig. 28 View of the reassembled platform and façade of the central sanctuary (view from the east)

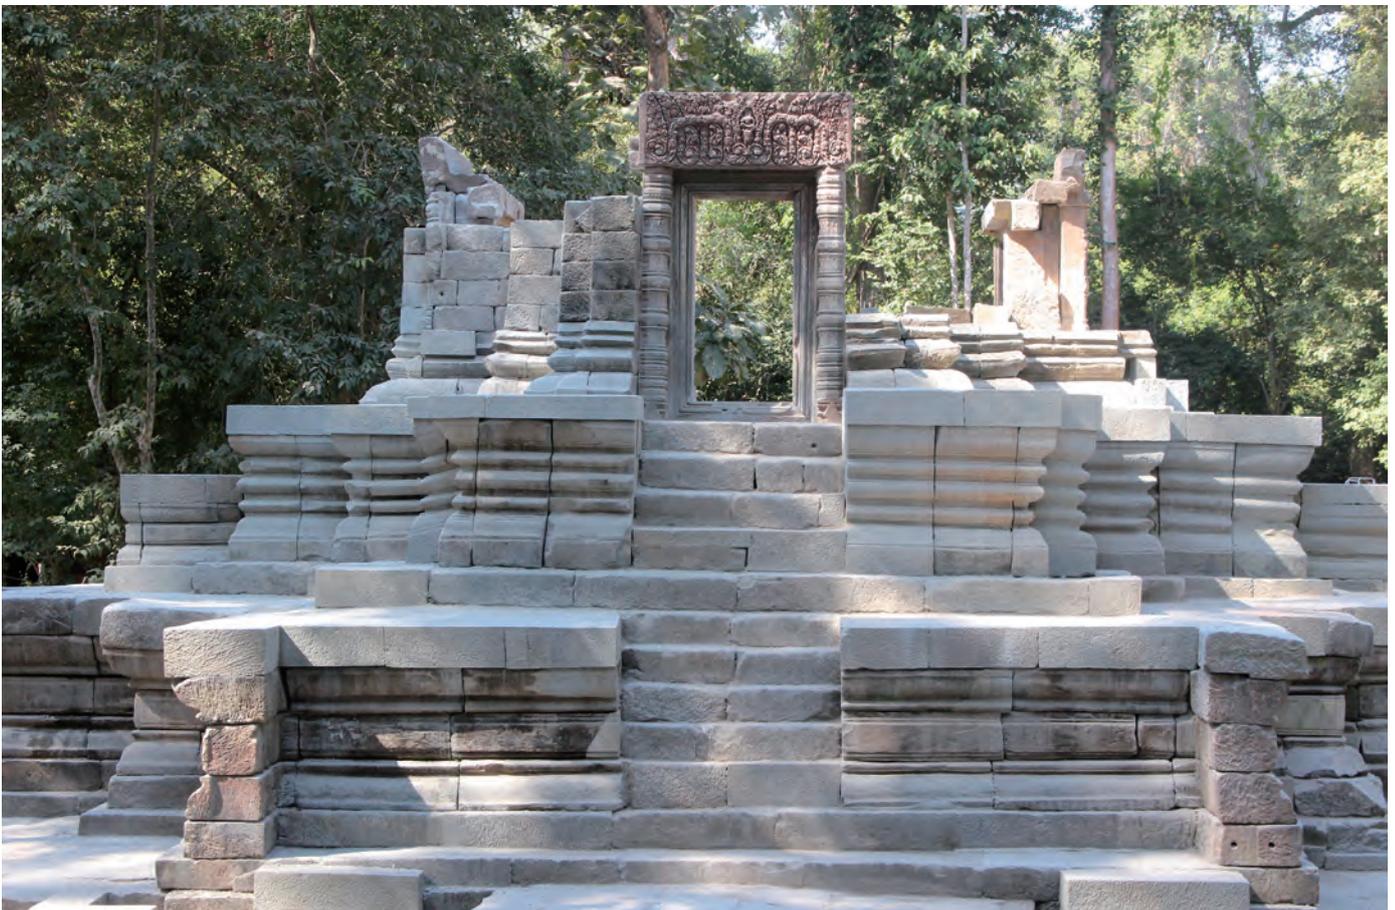
Fig. 29 View of the reassembled middle and upper platform and façade of the central sanctuary (view from the east)

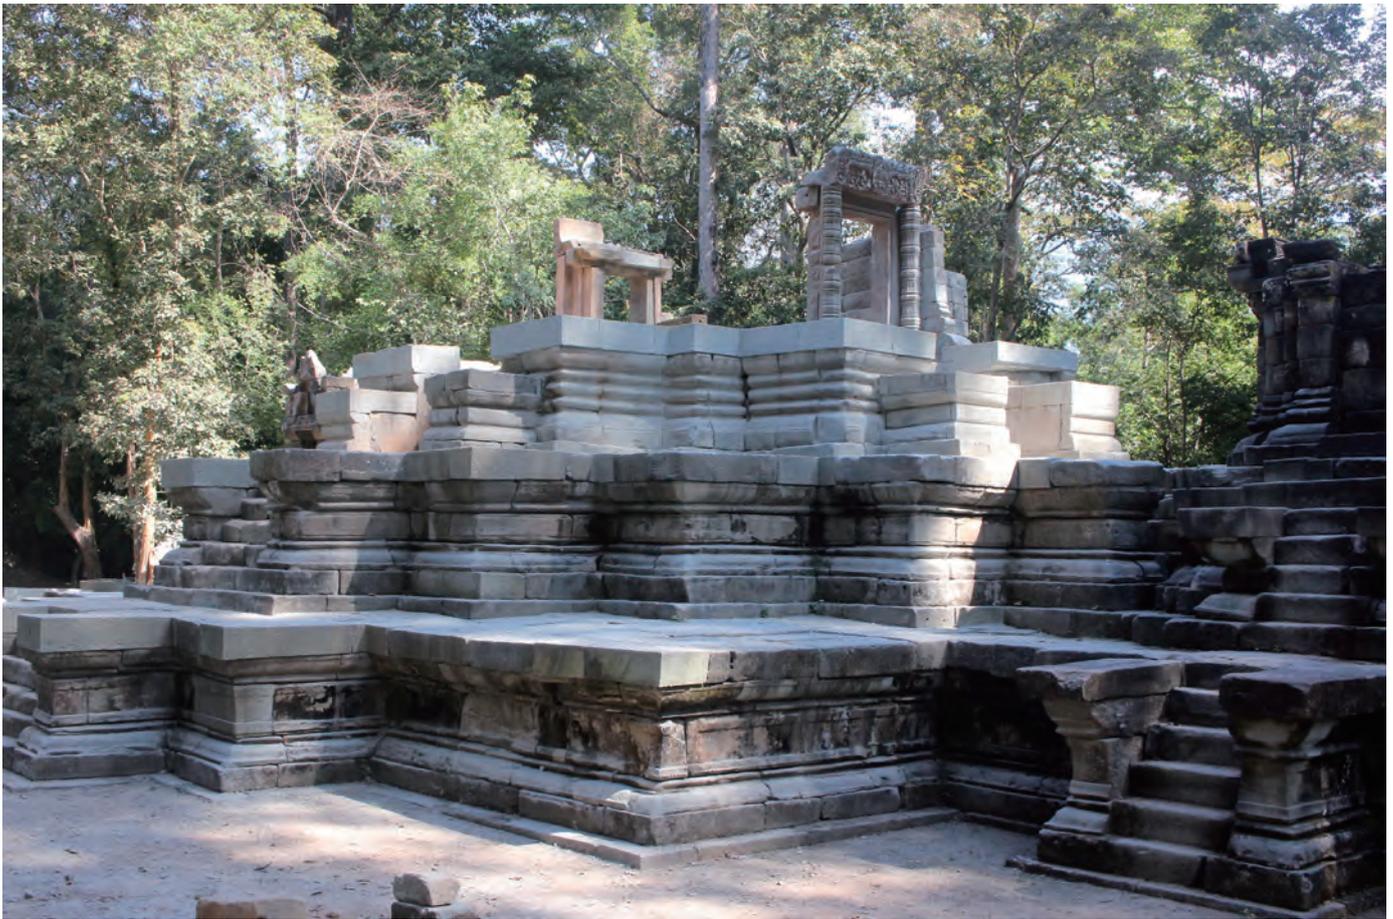
Fig. 30 View of the reassembled platform and façade of the central sanctuary (view from the southeast)

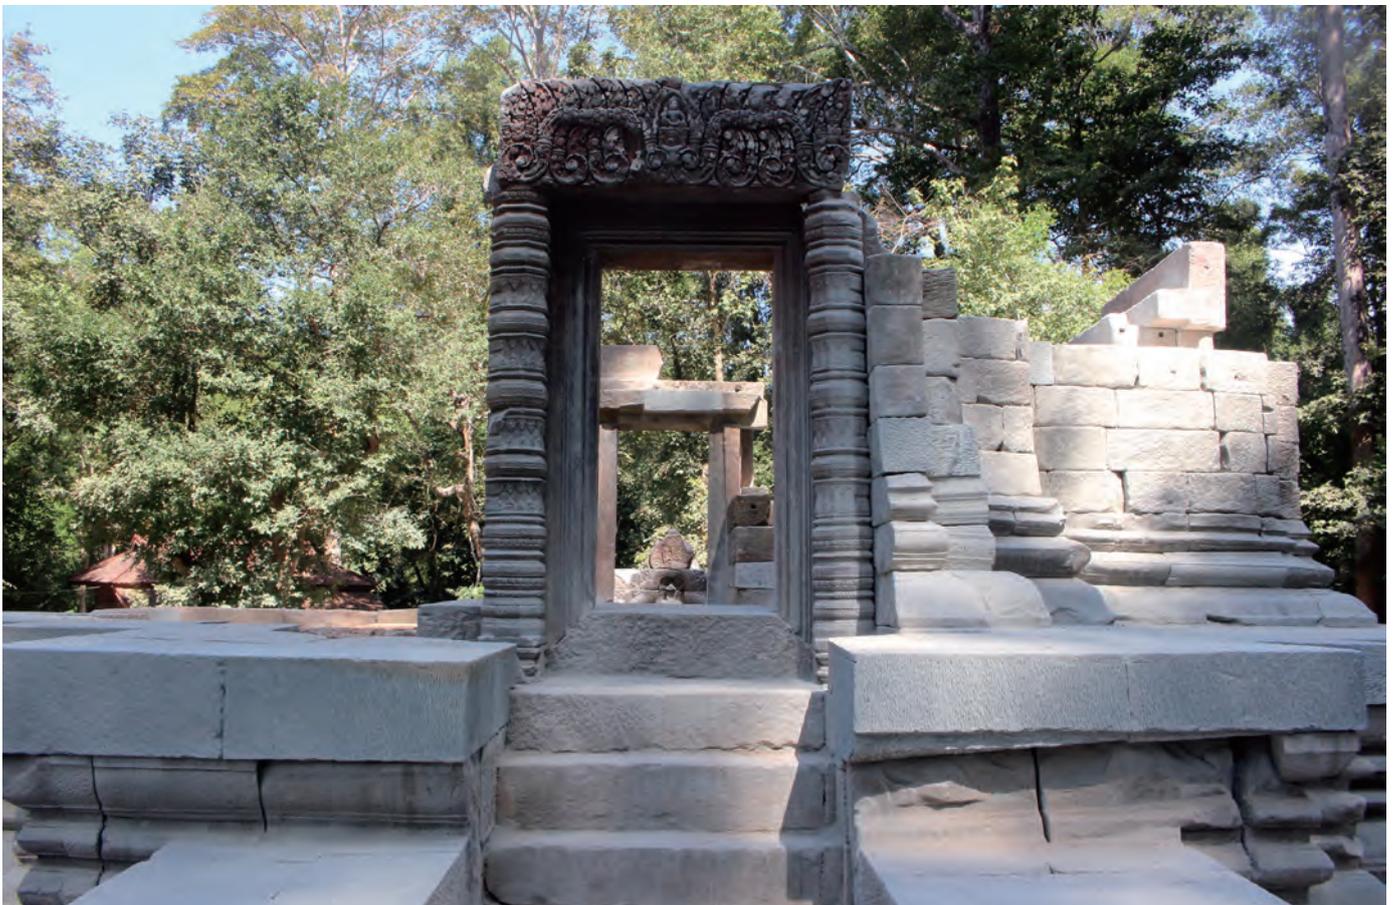
Fig. 31 View of the reassembled south façade of the central sanctuary (view from the south)

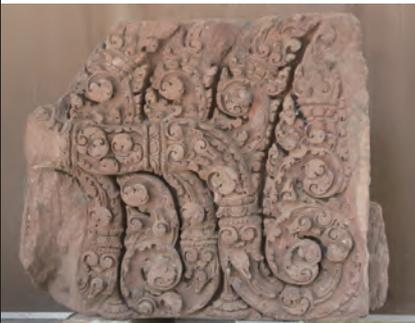
N424	42	48	35	Lintel	Western façade of central sanctuary

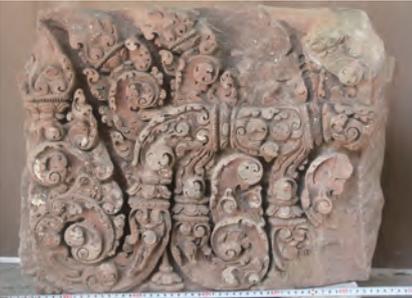
N425	75	47	36	Lintel	Western façade of central sanctuary

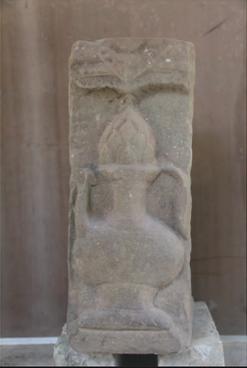
N435	18	46.5	36	Pediment	Kendi Lotus bud Bird-shaped spout

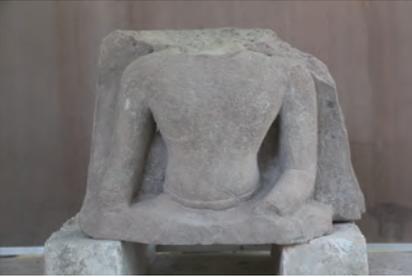
N437	34	25	16	Pediment	Seated Buddha with bhūmisparśa mudrā

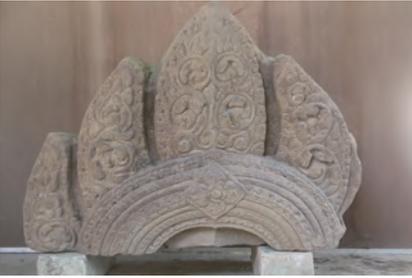
N445	64	50	23	Pediment

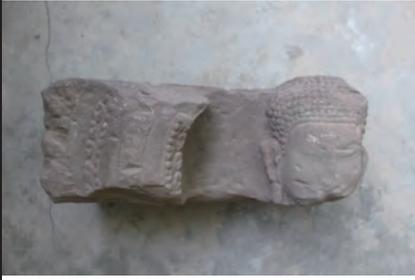
N451	52.5	20	36	Pediment	Head of Buddha

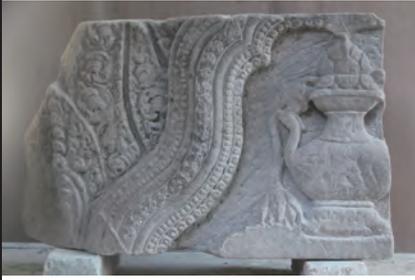
N452	70	43	21.5	Pediment	Kendi Lotus bud Bird-shaped spout

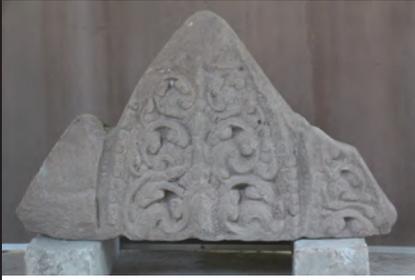
N453	55	33	14	Pediment

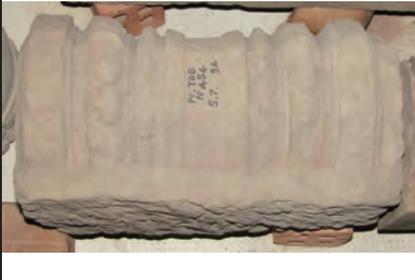
N454	20.5	38.5	19	Colonnette	Central sanctuary
