修復盛土の改良とオーセンティシティ Consolidation and Authenticity of the Restored Soil

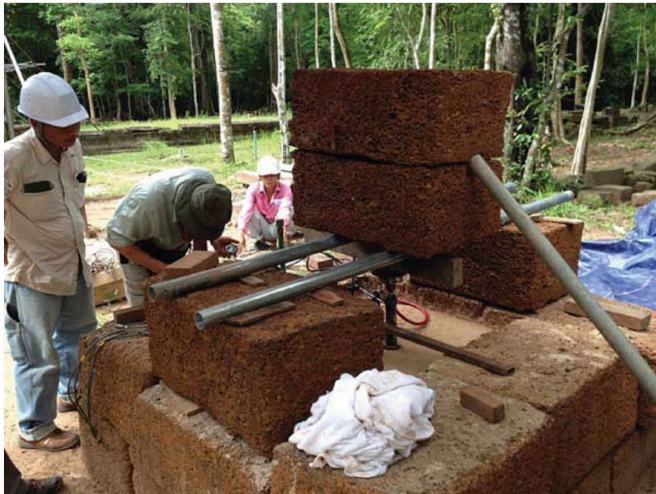
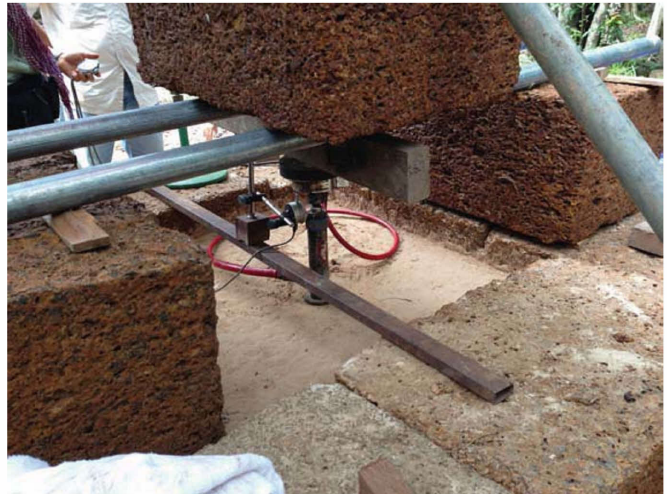
試験盛土による支持力と耐侵食性の確認
Confirmation of bearing capacity and erosion resistance of test soils

そこで私たちは、オリジナルの基壇盛土を構成する粗砂に、若干の粘性土と消石灰、ラテライト粉末を混ぜあわせ、改良土を作ることにしました。そしてその材料を用いて試験盛土を作製し、支持力と耐侵食性の実験をおこなうことで、十分な強度をもつ改良土を作ることに成功しました。

Thus, we decided to prepare consolidated soil by mixing the coarse sand of the original foundation earth fill with small amounts of clay, slaked lime and laterite powder. By using these materials to prepare a sample of test earth fill and testing its bearing strength and anti-erosion properties, we succeeded in creating consolidated soil that has sufficient strength.

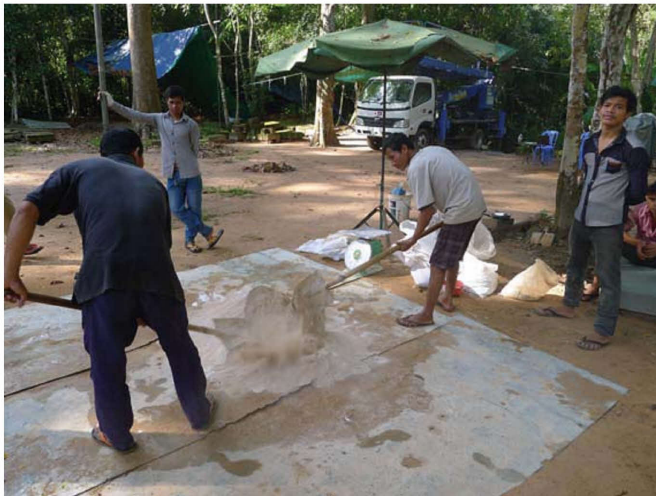
改良土を作るため、もともとの基壇盛土（粗砂）に若干の粘性土、消石灰およびラテライト粉末を混合する
To consolidate the foundation soil, a small amount of clay, slaked lime and laterite powder were added to the original foundation soil (coarse sand)

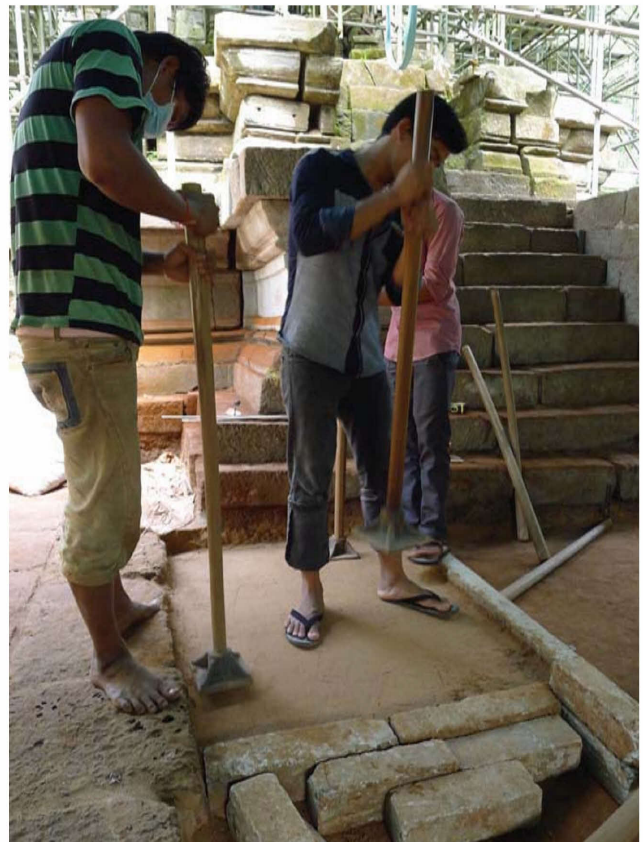
「象の足」と呼ばれる棒を用いて改良土の締め固めをおこなう
Compacting foundation soil using an "elephant's foot" rammer
