Chapter 3: Door Elements on the Central Sanctuary of Western Prasat Top Temple (Monument 486)

Sok Keo Sovannara

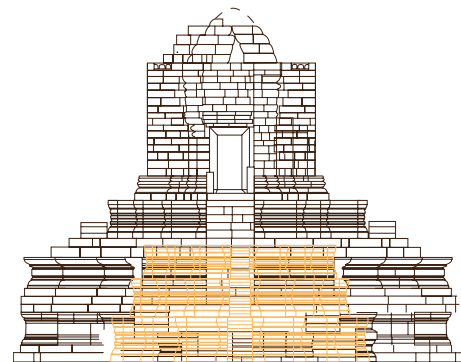
Fig. 2 Reconstruction image of Stage 2

When the former sanctuary presumably collapsed a new grey sandstone structure (Fig.2)—the currently visible sanctuary— was built over the original laterite base. The structure was again a single tower, but with four sets of stairs placed at each cardinal direction. The elements of the door frames and decorative blocks, such as colonnettes and lintels, were made of red sandstone. The sanctuary was constructed with four doors open to each cardinal direction. Two of the door frames were made of red and pale-yellow sandstone blocks. The other two were made of grey sandstone. These door frame blocks seem to be reused stones. All four doors were also accompanied and decorated with red sandstone colonnettes and lintels.

The upper pediments, or frontons, were decorated with a sitting Buddha (in the Bhumisparasa mudra position) and figures typical of the style of the Post-Bayon or Post-Angkor periods.

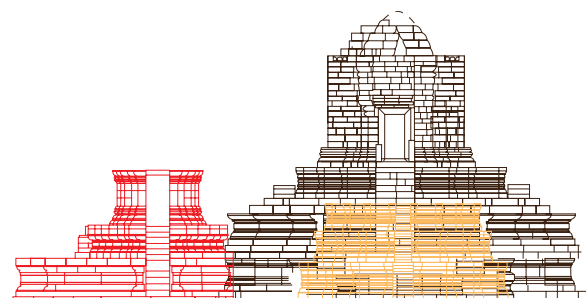
Fig. 3 Reconstruction image of Stage 3

The southern sandstone sanctuary (Fig.3) was constructed over the southern staircase of the central sanctuary built in Stage 2. After we dismantled the upper sanctuary and conducted an excavation of the fills inside this structure, we revealed that this tower was built on top of the southern stairs of the main, central tower (3). However, this southern tower has only one open door, with the other three being false doors. This southern tower has no colonnette or lintel, but does have four pediments with a seated Buddha image set up in the four cardinal directions.

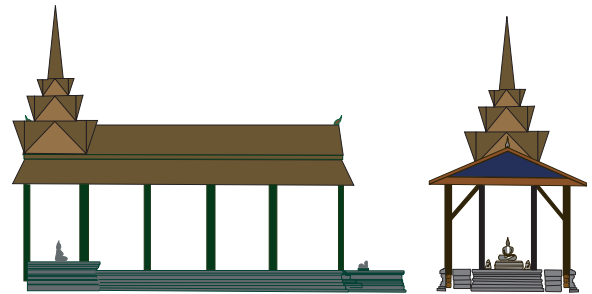
Fig.5 Proposed visualisation of the Buddhist Terrace

A Theravada Buddhist terrace was added to the east of the central sanctuary. This Buddhist terrace probably contained a sheltered wooden structure covered by brown glazed roof tiles 6.

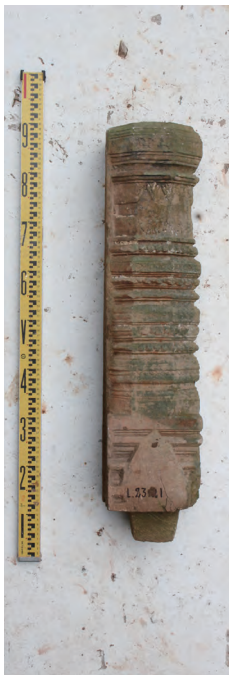
Fig.9 A part of the Colonnette from the eastern face

2.2.a. Eastern Colonnets

The two colonnettes of the eastern door are made from red sandstone, measuring about 1.7m high and 0.185m wide. The colonnettes are roughly rectangular in shape with the lower part carved with four corners while the body is carved into a heptagonal (7-sided) shape. The two long sides connect to the door frame and wall, while the other five are decorated with motifs. The southern colonnette is decorated on three sides only. The northern colonnette is decorated on five corners.

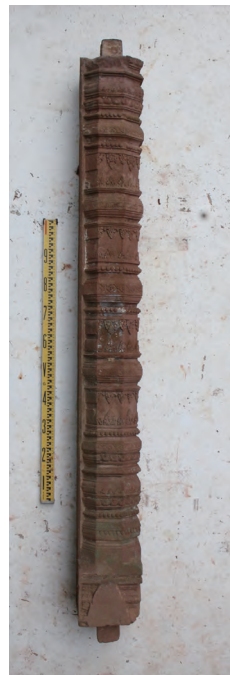
Fig.11 Colonnette from Southern face

2.2.c. Southern Colonnets

The two colonnettes of the southern door are made from light-red sandstone, measuring about 1.86m high and 0.22m wide. The east-side colonnette is rectangular, with the lower part being four cornered while the body is heptagonal. The west-side colonnette is eight sided. Normally, two long sides are connected to the door frame and wall while the other five are decorated. These two colonnettes are decorated on five sides.

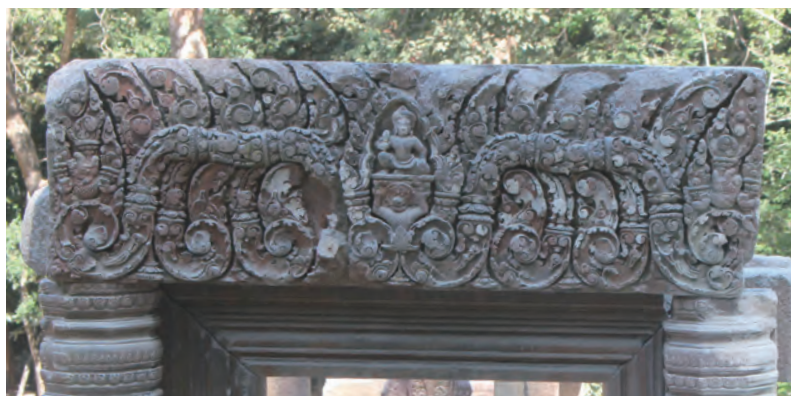
Fig.15 Southern lintel

2.3.c. Southern Lintel (Fig.15)

This lintel remained in place before dismantling. It is made from red sandstone measuring 1.32m long, 0.465m wide and 0.425m high. The middle part is designed with an image of the god sitting on the lion, carrying a stick or sword in his right hand that could be Ketu.

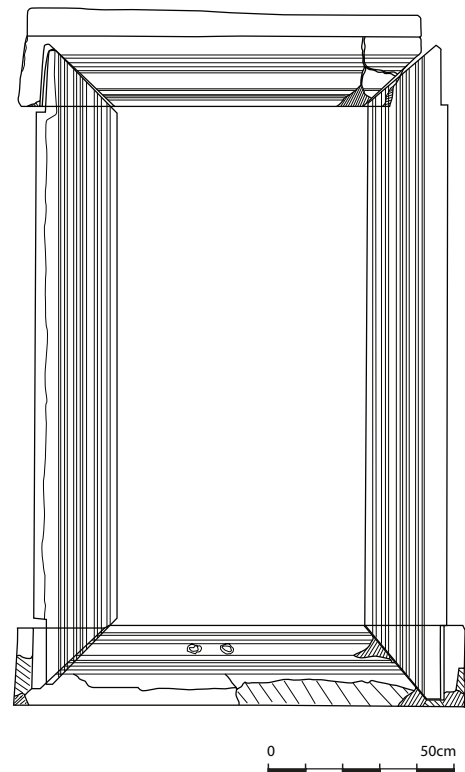
Fig.17 Drawing of the eastern door

3.a.a. Eastern Door Frame (Fig.17)

The reinstallation of the eastern door's frames revealed a problem in the height of the north-vertical frame. There is gap between the vertical and the lower frame, hidden behind the colonnette. The space was originally filled with small blocks or chips of sandstone and they were stabilized well.

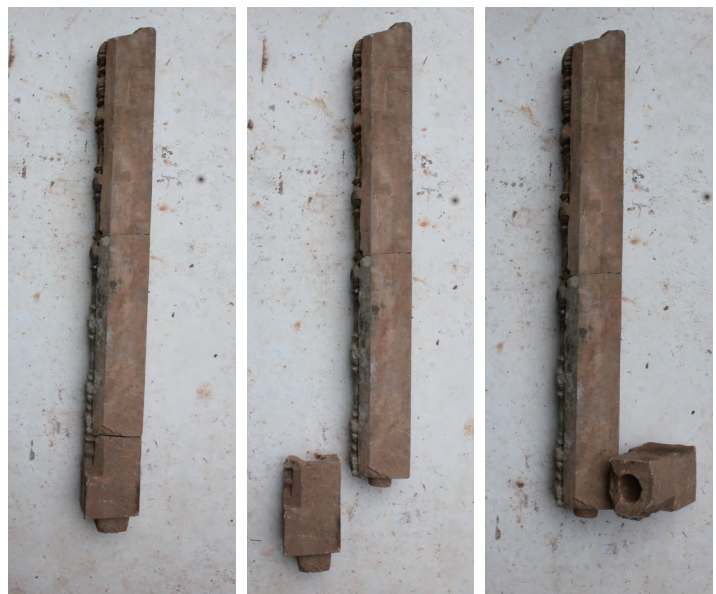
Fig.20 Colonnettes from the western door- southern side

There are eight colonnettes in this sanctuary. But they are not the same sizes or heights. The colonnettes of the eastern door and western doors are the same size but different heights. The colonnettes of the southern and northern doors are also the same size but bigger than the eastern and western doors. However, the corners of all these colonnettes are not the same sizes or numbers. Normally, the colonnettes are divided into three main parts: head, body and bottom (Fig.24). The colonnettes of the eastern, western and southern doors retain their original sizes and parts. The colonnettes of the northern door cut the head-part to conform to the height of the door frames. Interestingly, we have found that the southern colonnette of the western door was repaired before installation. This was confirmed when we dismantled it. The lower part was probably, and accidentally, broken but another piece measuring about 38cm high (Fig.20) was added. The original

part had a hole cut into the bottom, while a new block was chiseled with a tenon for inserting into the hole of the old colonnette.

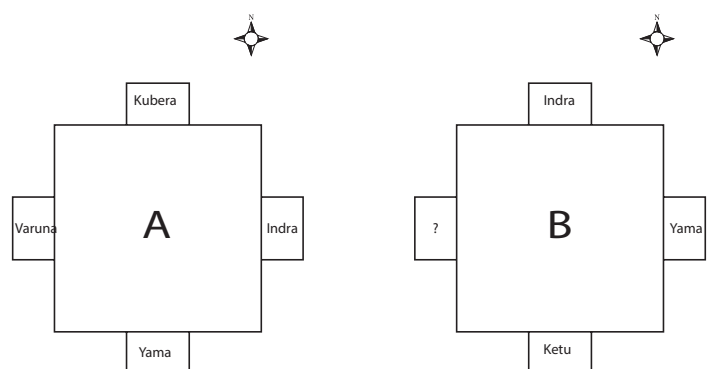
Fig.21 Arrangement of lintels decorated with Hindu Gods: A. regular direction. B. Western Prasat Top

There are four lintels that were used for each door. These lintels are not the same size. Generally, a single tower was designed with regular and equal sizes of doors and elements. But in this central sanctuary, we have observed that every element seems to be reused with irregular sizes or placement (i.e., directions). The confusion with these lintels is related to the functions and directions of the god-images designed on the lintels. Normally, the lintel decorated with the image of a god sitting on an elephant must be Indra and positioned in the east. But in the central sanctuary of Western Prasat Top, the Indra lintel was placed on the northern door. This is wrong. It was probably the mistake of the constructors who did not take an interest in the former function, and meaning, of the lintel. Also, the eastern lintel shows the god Kubera, who controls the northern direction, but it was placed over the eastern door. The southern lintel presents an image of the god sitting on a lion that could be Ketu, who is rarely sculpted on lintels in Khmer art. Normally, the god who controls the southern direction is Yama, sitting on a buffalo.

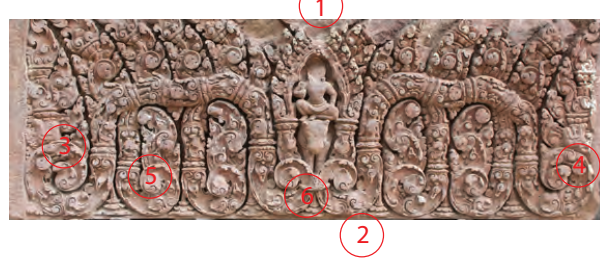
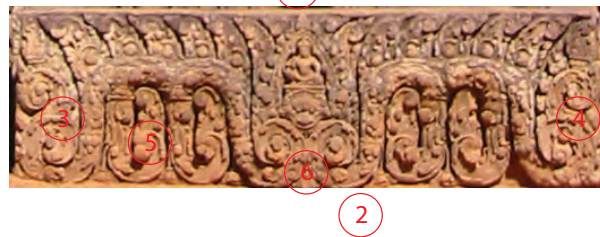
Fig.22 Comparison of lintels at Western Prasat Top and Banteay Srei

4.1. Lintel (Fig.22)

- Absent of the original upper edge (1)
- Absent of the original lower edge (2)
- Bow arcs appear from the central medallion outward, created as Hamsa (swan) tails (3)
- Presence of lion heads spitting out a

cluster of flowers (4)

-Garlands of flowers spiralling like snail shell (5)

-Tied ring as Makuta (crown) at the ends of bow arcs in the central point (6)

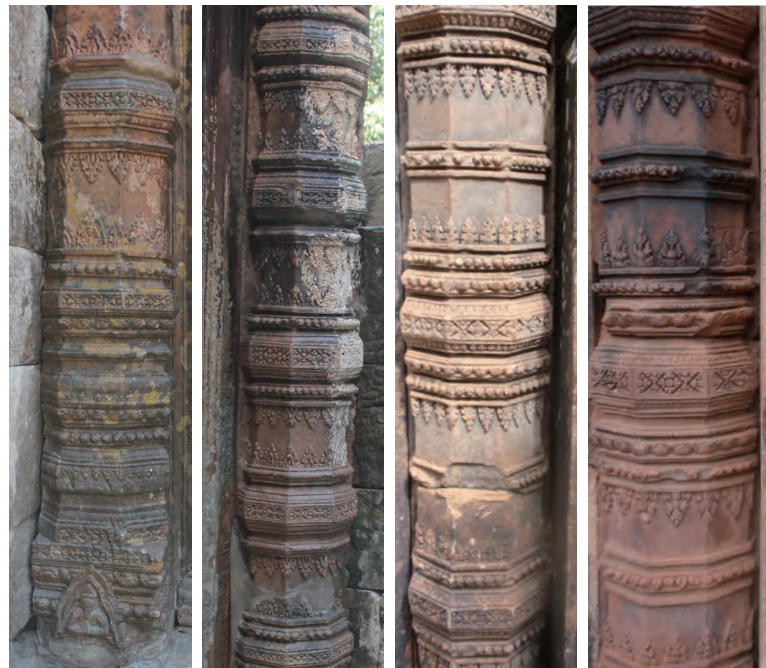
Fig.23 Comparison of colonnettes at Western Prasat Top and Banteay Srei

4.2. Colonnets (Fig.23)

There are some similarities of the colonnettes at Western Prasat Top temple and Banteay Srei temple.

-Most colonnettes have seven sides or corners

-The Colonnets are divided into three parts: heads, bodies and bottoms.

-The Heads are designed with multiple rings decorated by lotus-petal and fish-egg motifs.

-The bodies are divided into three parts such as: ½ ring, and two ¼ rings decorated with multiple motifs.

-The ½ rings are normally created by a rectangular motif of a flower associated with two lines of flower blooms, and two lines of fire-leaf (face down and face up) motifs.

-The heads and bottoms are decorated with the same motifs.

-The lower parts of the bottoms are square shaped and decorated with images of figures praying in Kudu designs.
